**STUDY ON INSPECTION AND EVALUATION OF  
DAMAGED STEEL STRUCTURE IN THAILAND**

**A THESIS SUBMITTED IN PARTIAL FULFILLMENT OF THE  
REQUIREMENTS FOR THE DEGREE OF MASTER OF SCIENCE  
(ENGINEERING AND TECHNOLOGY)**

**SIRINDHORN INTERNATIONAL INSTITUTE OF TECHNOLOGY**

**ACADEMIC YEAR 2015**

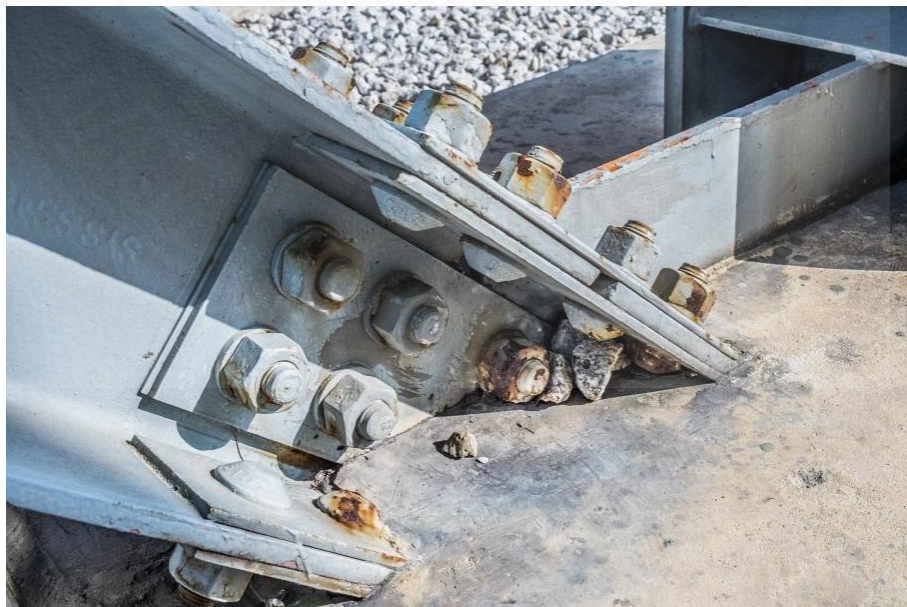
Fig 4.8 and Fig 4.9 show the damage on the bolt connection due to the deterioration of the coating and corrosion.

Fig 4.8 Blistering and flaking of paint on bolt at Power Plant A (1)

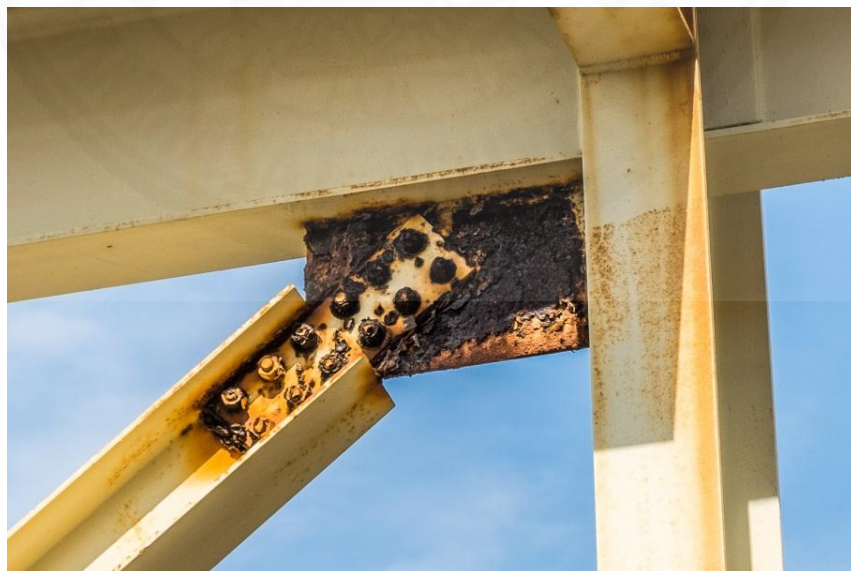
Shown in Fig 4.13 to Fig 4.15 is the corrosion damage on steel bolt connections, the corrosion covers on both bolt itself and the steel plate which used to connect each steel section with the bolt, some of the connection was entirely covered by corrosion.

Fig 4.13 Severe corrosion on steel bolt connection in Power Plant B

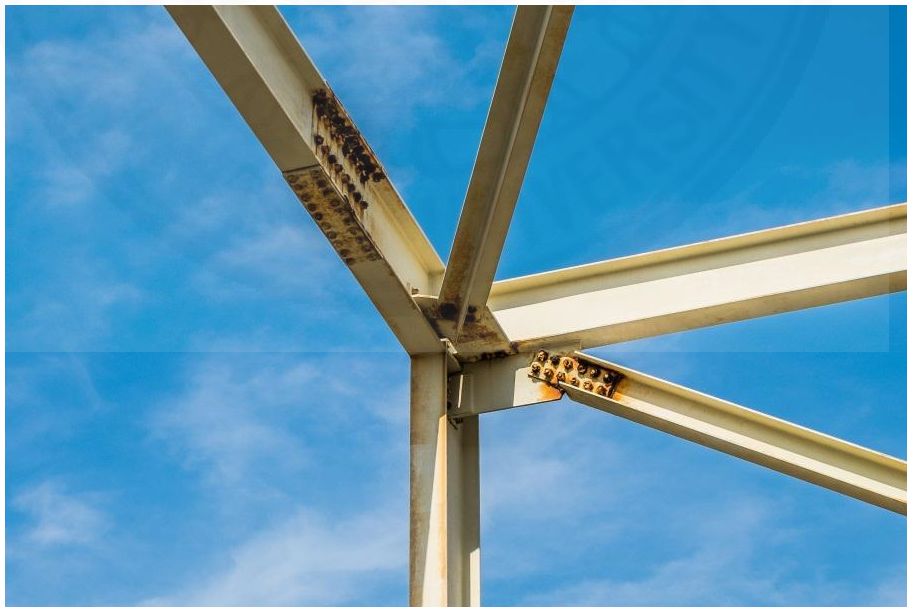
Fig 4.15 Corrosion on the steel bolt connection at Power Plant B (2)

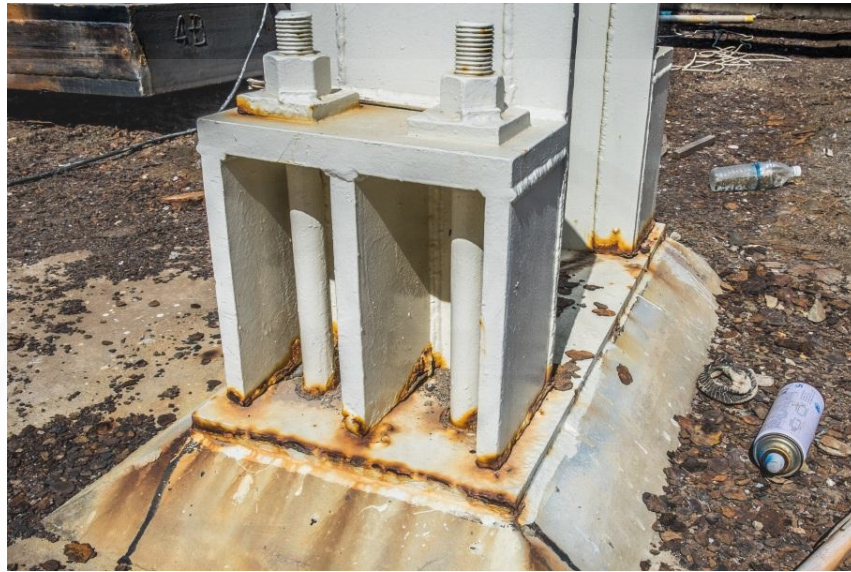
Shown in Fig 4.16 to Fig 4.19 is the corrosion damage at the bottom of the column where the column and the steel plate on the footing were connected, the connection used in these figures were bolt connection, the bottom of the column was not welded to the steel plate as shown in Fig 4.20, but the column was fixed to the footing by bolt.

Fig 4.16 Corrosion on the steel column connection at Power Plant B

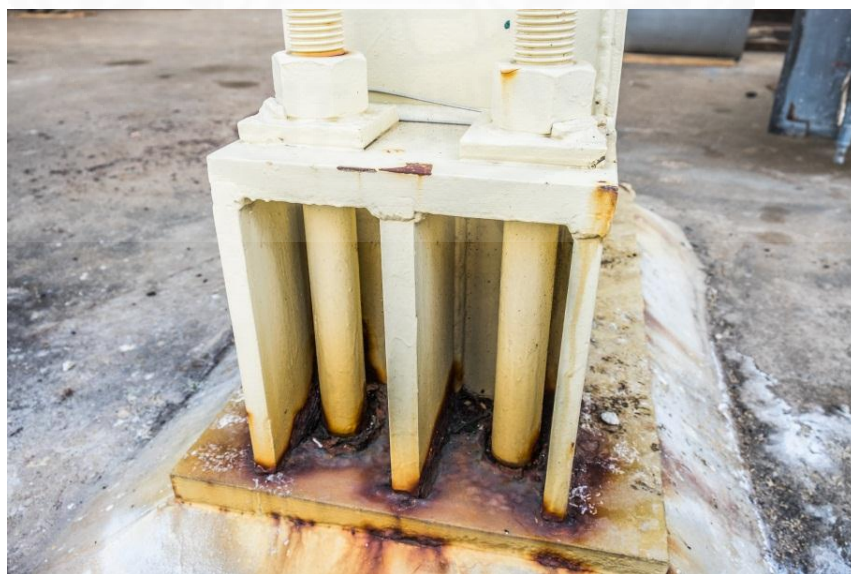
Fig 4.17 Corrosion on the steel column connection at Power Plant B

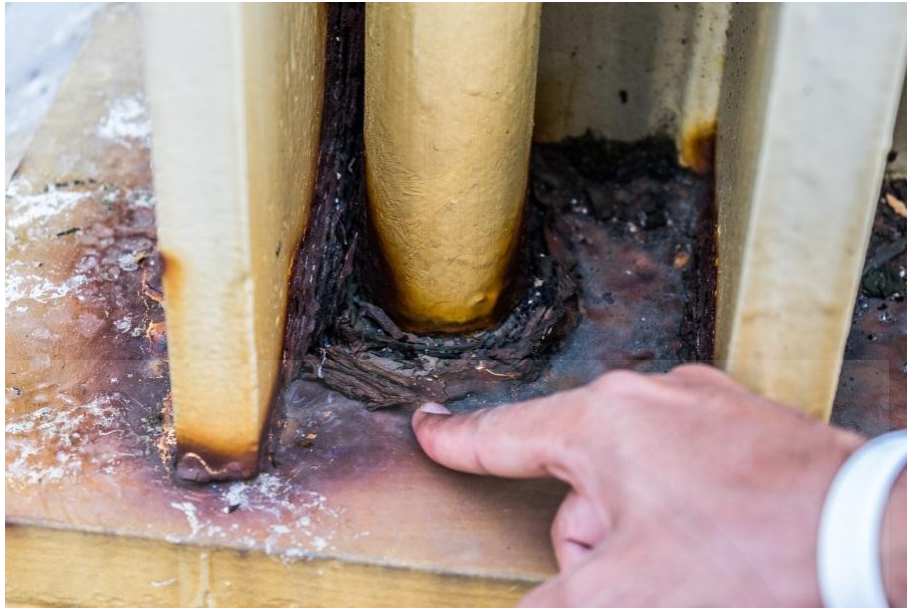
Fig 4.18 Corrosion at the bottom of the column in Power Plant B (1)

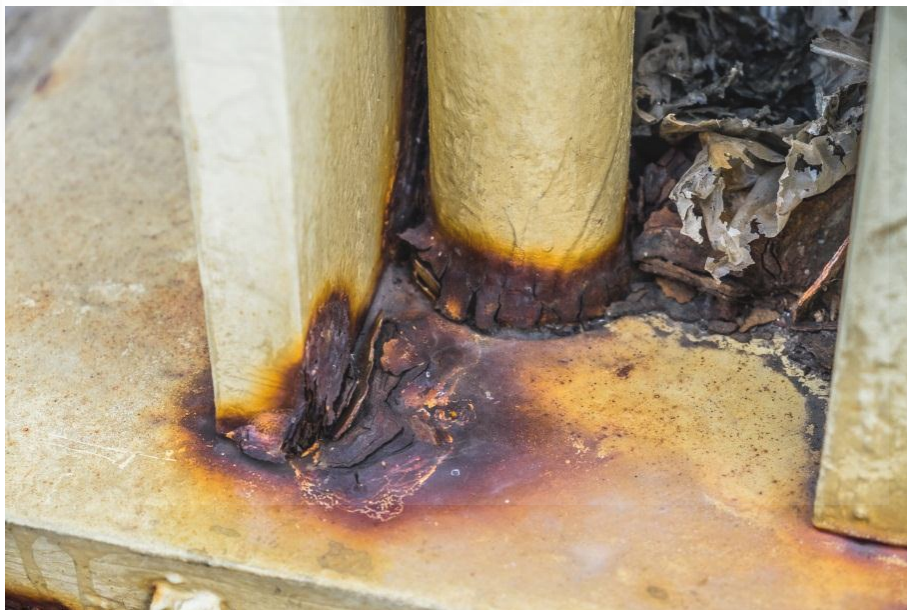
Fig 4.19 Corrosion at the bottom of the column in Power Plant B (2)

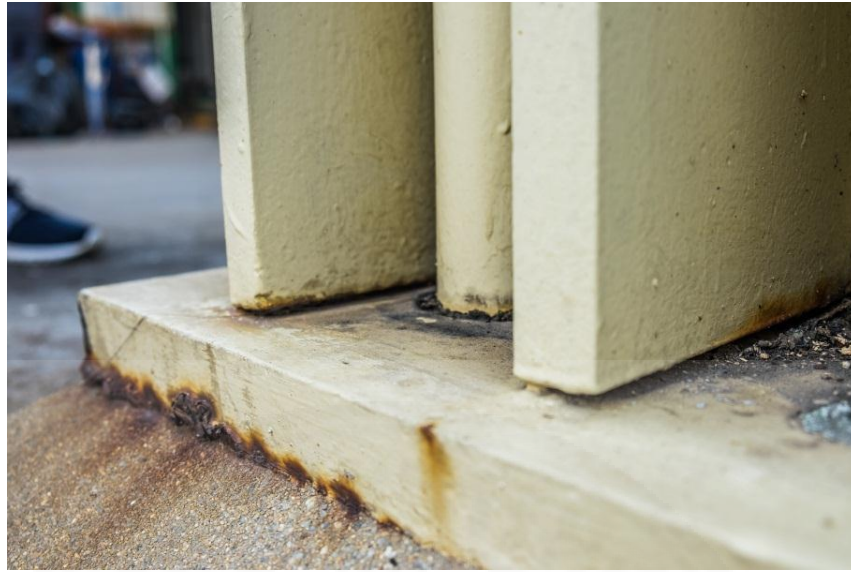
Fig 4.20 Space between steel column and steel plate in Power Plant B

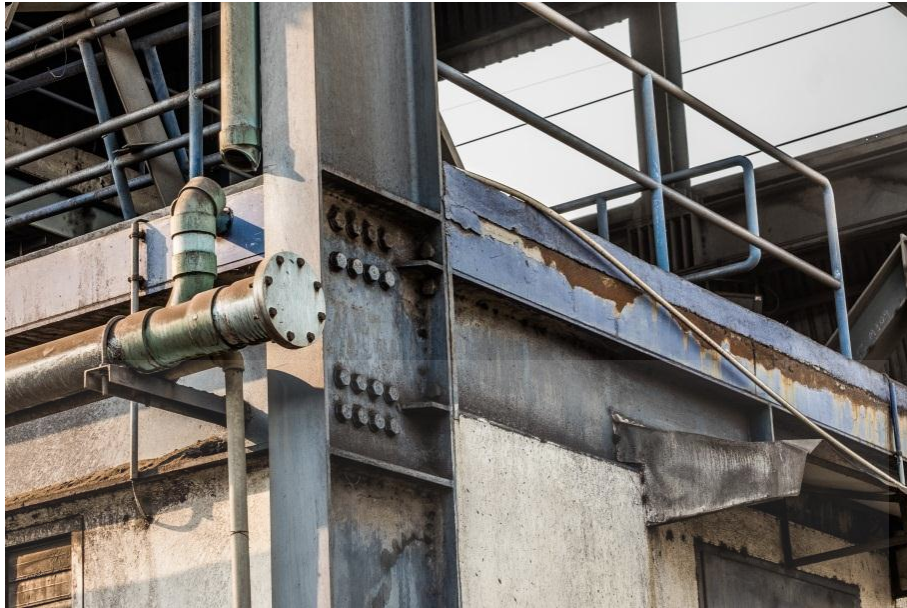
But unlike the steel section at the construction site, the steel structures at the old power plant found to be deteriorated due to the corrosion damage from the flaking of the anti-corrosive paint, as shown in Fig 4.27 on the right side of the figure that the surface of the steel was exposed to the environment, and some of the steel section was consumed by the corrosion.

Fig 4.27 Flaking and corrosion of the steel coating at Power Plant C

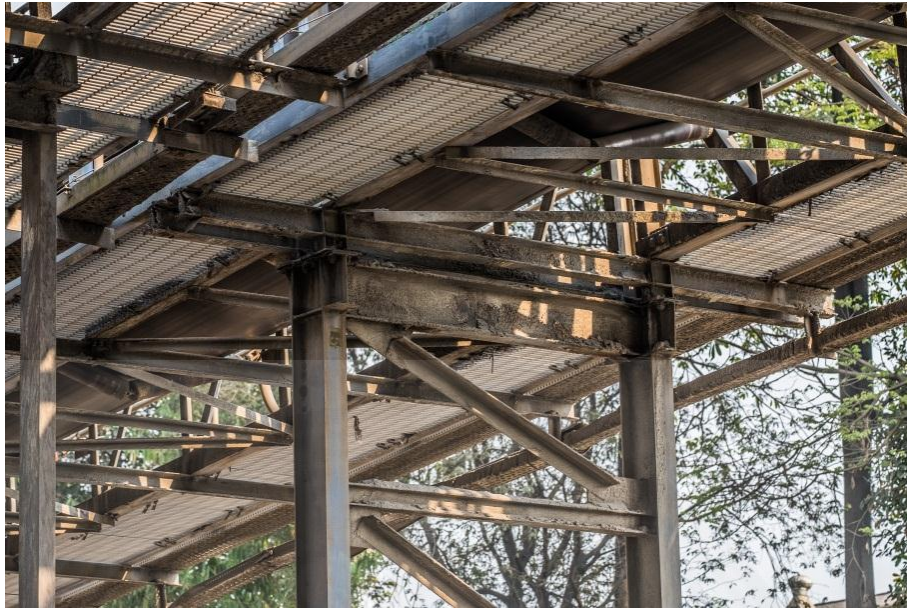
Lastly, the other damage found besides corrosion and deterioration of anti-corrosive coating on the steel surface are at the belt conveyors, shown in Fig 00 and Fig 00 that, on the steel structure surface was covered by dust and coal which cause the steel to be deteriorated.

Fig 4.28 Deterioration on the steel conveyor at Power Plant C (1)

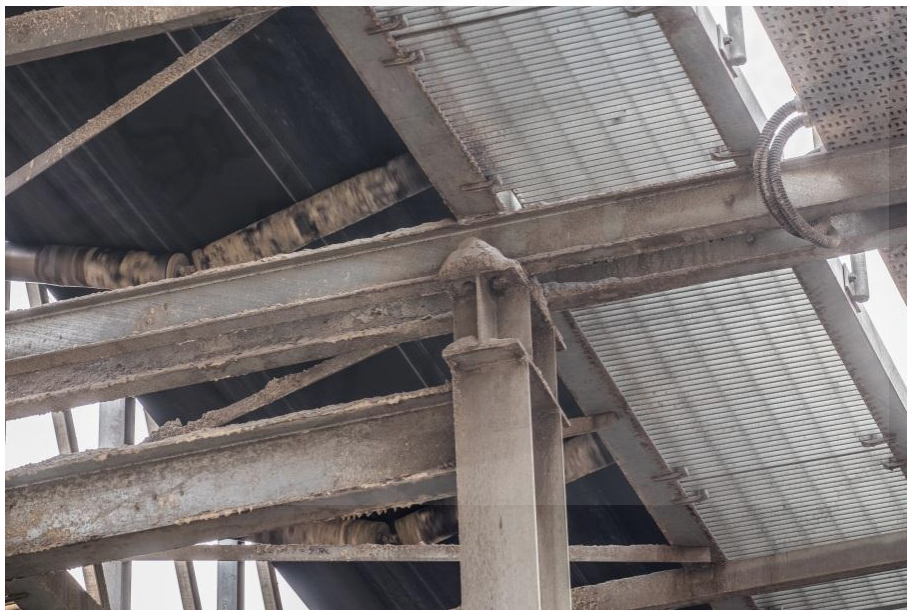
Fig 4.29 Deterioration on the steel conveyor at Power Plant C (2)

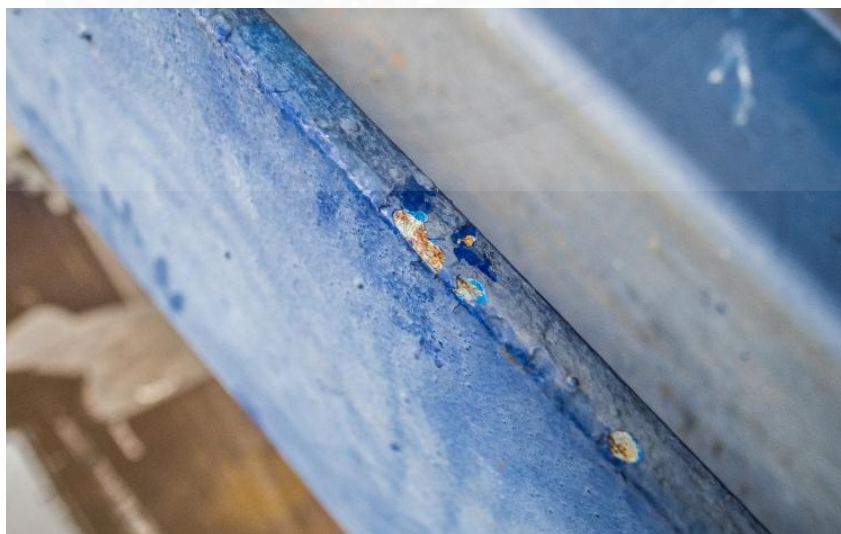
The visual inspection results show that the steel structure has minor deterioration of anti-corrosive paint such as, flaking, and intensive change in appearance (color), causing minor corrosion damage on the unprotected steel surface located at the steel section and connection shown in Fig 4.35 to Fig 4.37, the inspection results were recorded in Table 4.4.

Fig 4.35 Flaking of anti-corrosive paint at Power Plant D

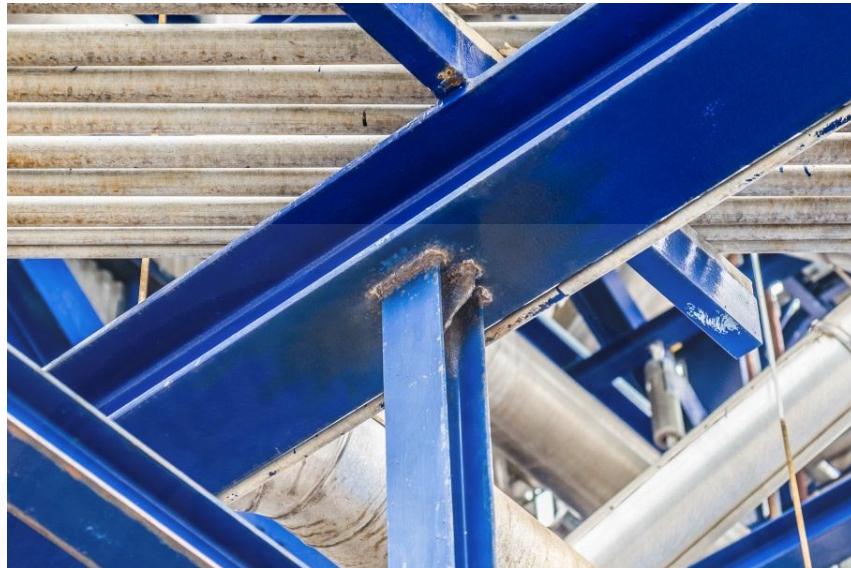
Fig 4.36 shows the corrosion damage on the weld surface of a beam-column structure in Power Plant D.

Fig 4.36 Rusting on the welded connection of steel at Power Plant D

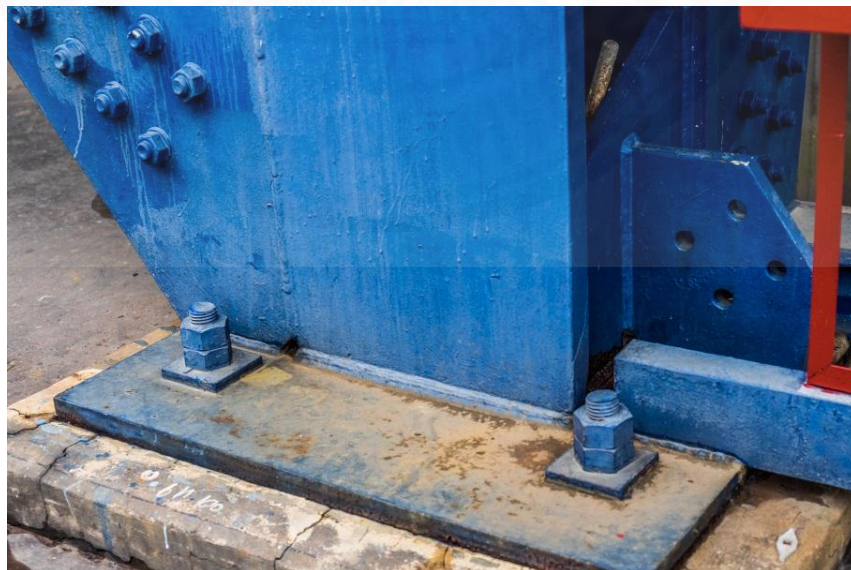
As shown in Fig 4.37, the intensity change of anti-corrosive paint due to the deterioration of the paint over long usage without maintenance work.

Fig 4.37 The intensity change of anti-corrosive paint in Power Plant D

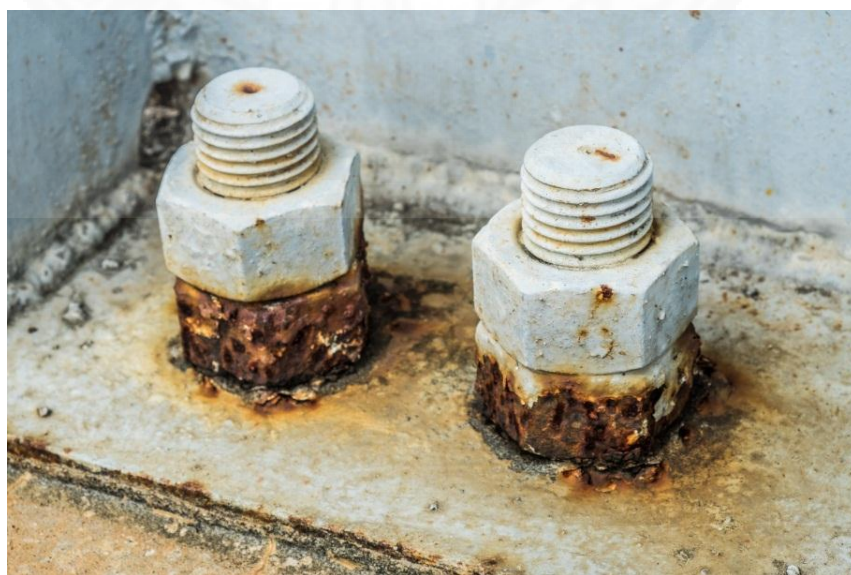
Fig 4.44 shows the corrosion damage on the steel bolt, occurred by the moisture that penetrated into the gap between the bolt and the steel plant, this case can happen when the bolt connection was not painted entirely (missed at the gap), makes some area of the steel to be unprotected.

Fig 4.44 Corrosion damage on the bolt connection at Power Plant E

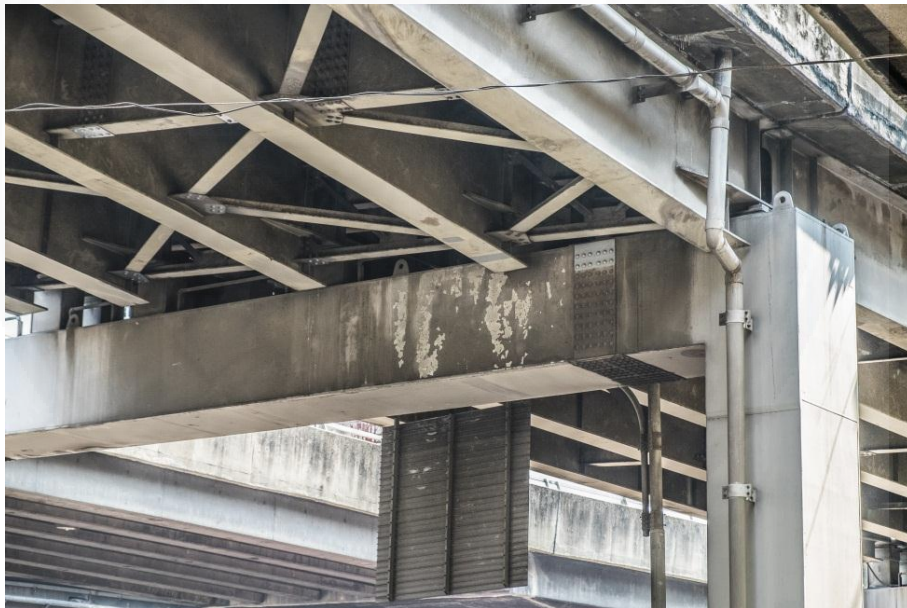
Fig 4.50 Flaking of paint on steel surface at Highway Bridge A

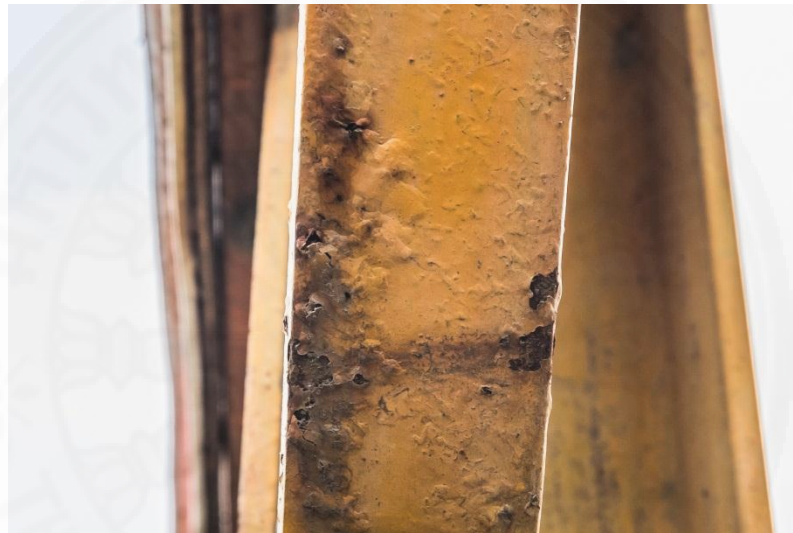
The inspection results show some severe paint defects such as flaking and blistering, as well as corrosion damage on the surface of the steel as shown in Fig 4.58 to Fig 4.66, and the inspection and evaluation results were recorded in Table 4.7 and Table 4.8.

Fig 4.58 Blistering and rusting of paint on Billboard A (1)

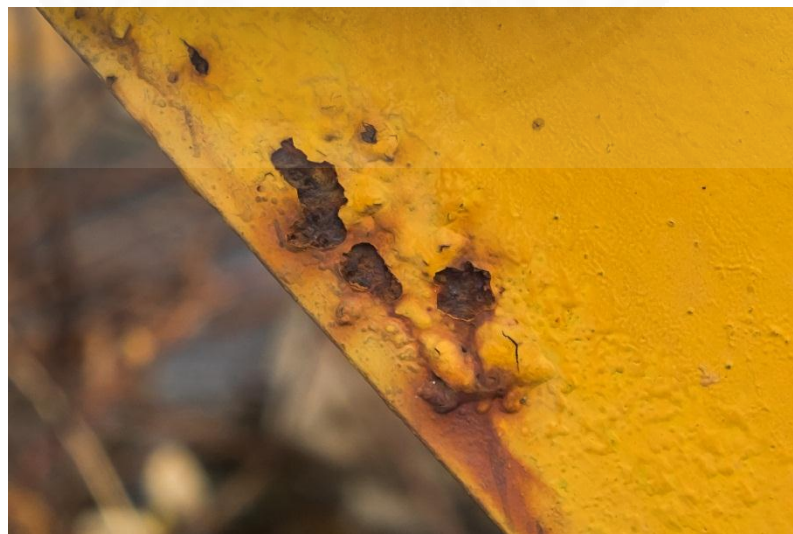
Fig 4.59 Blistering and rusting of paint on Billboard A (2)

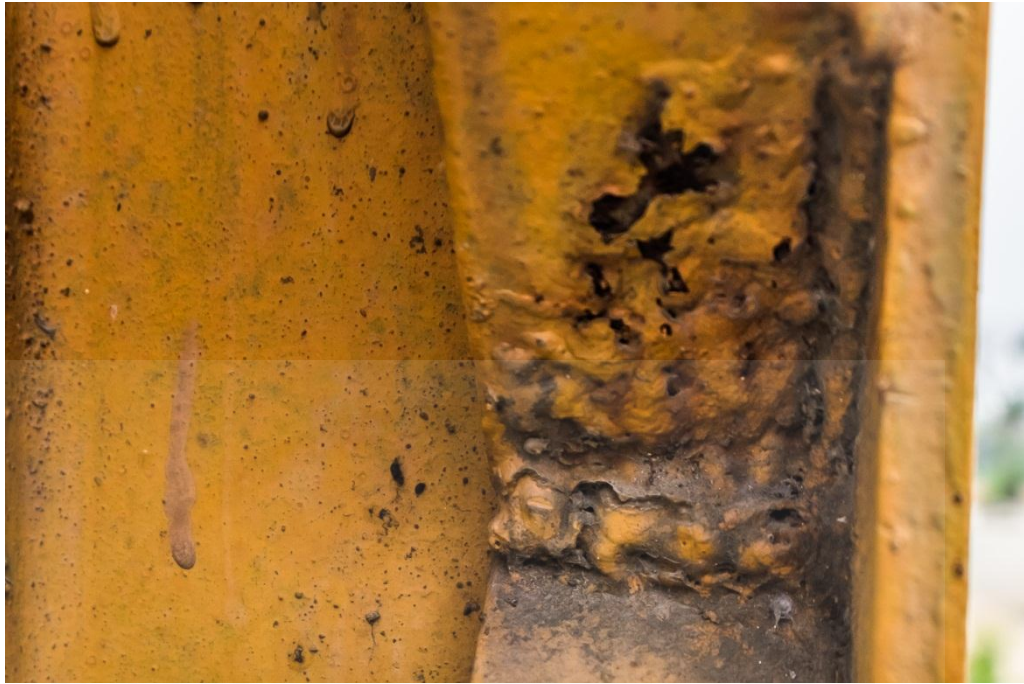
Fig 4.60 Blistering and rusting of paint on Billboard A (3)

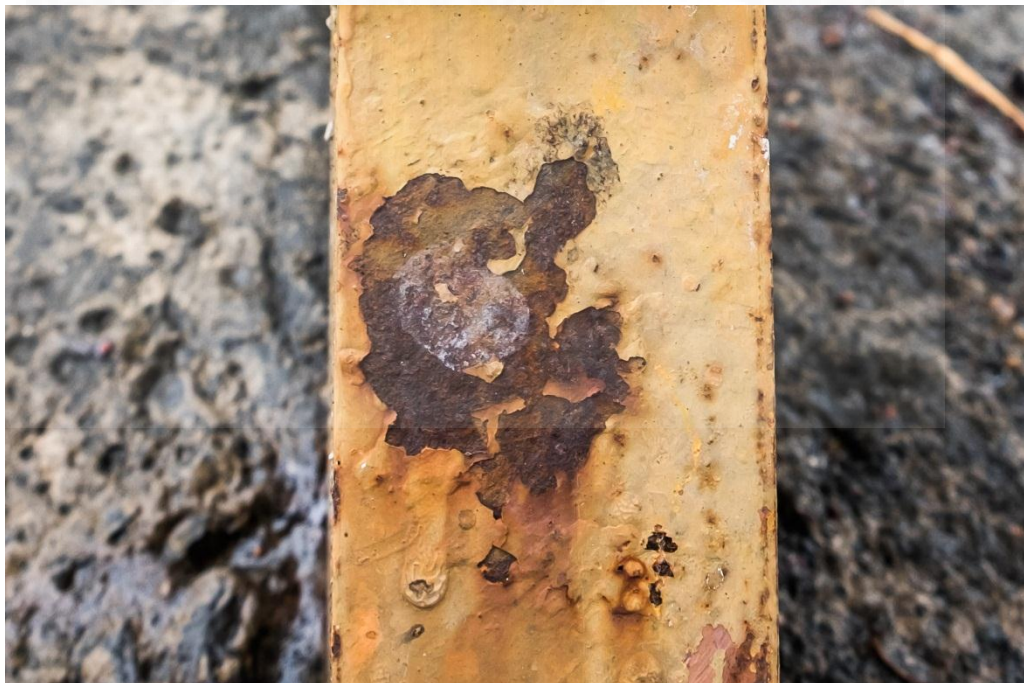
Fig 4.61 Flaking and rusting of paint on Billboard A (1)

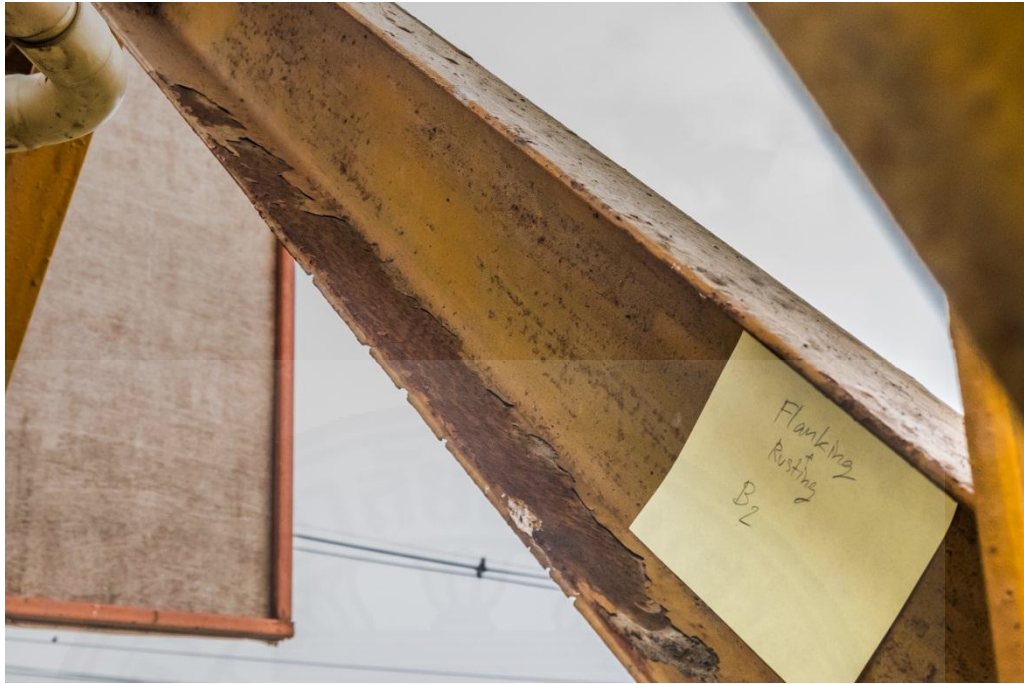
Fig 4.62 Flaking and rusting of paint on Billboard A (2)

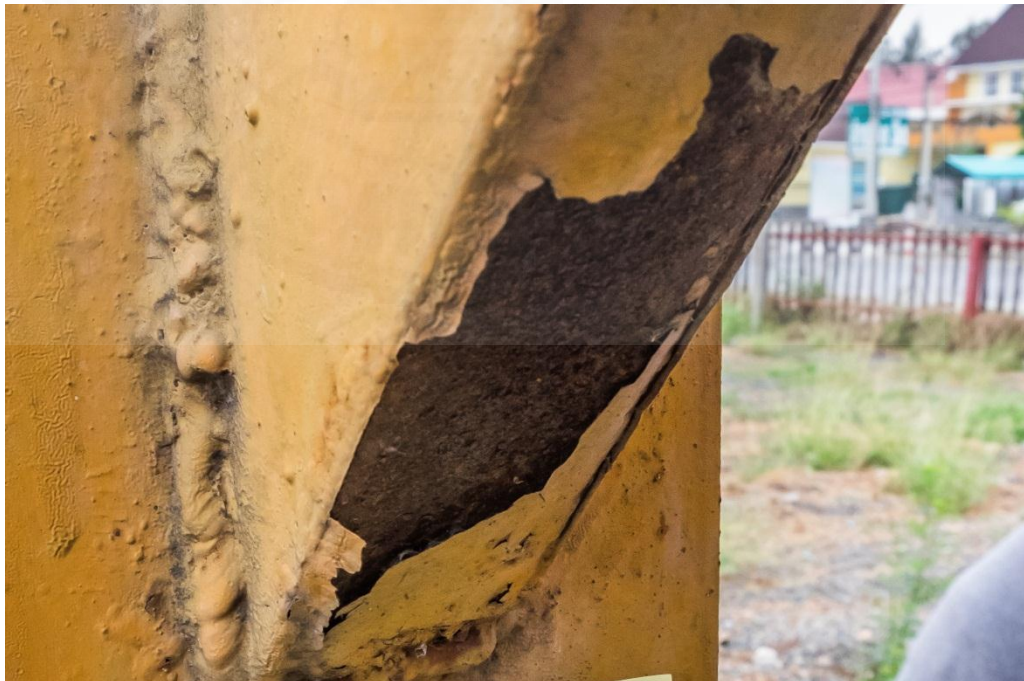
Fig 4.63 Flaking and rusting of paint on Billboard A (3)

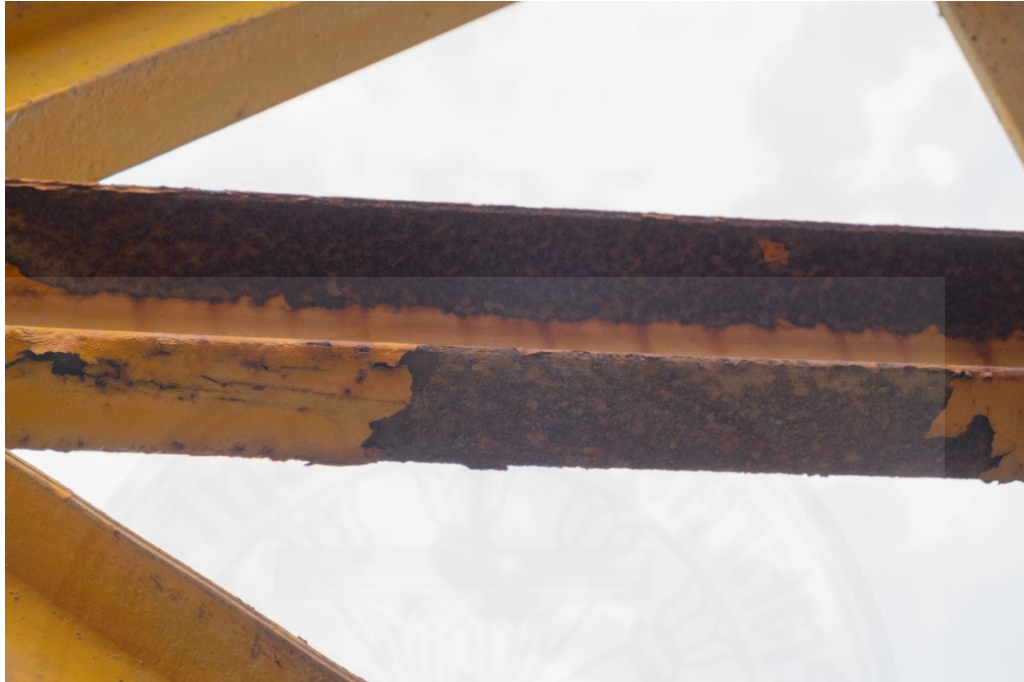
Fig 4.64 Flaking and rusting of paint on Billboard A (4)

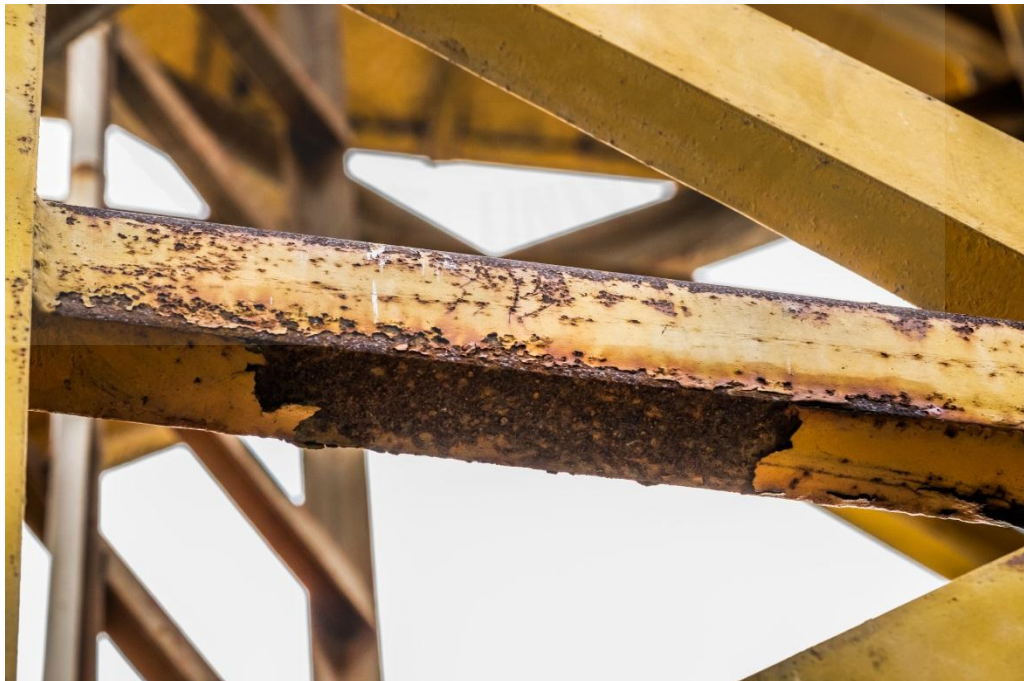
Fig 4.65 Flaking and rusting of paint on Billboard A (5)

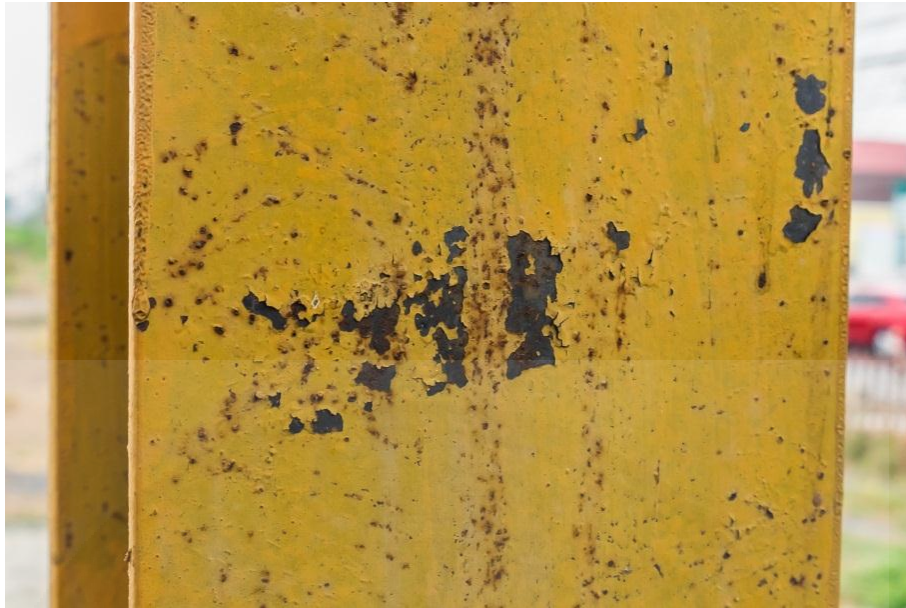
Fig 4.66 Flaking of paint on Billboard A

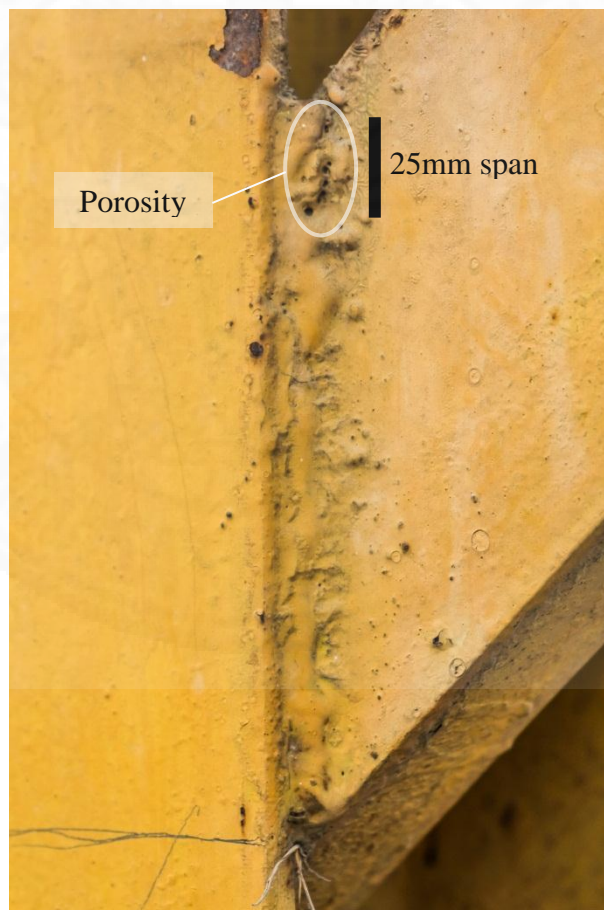
The inspection results show many serious weld defects mainly porosities and undercuts at the welding, the inspection results was recorded in the form of table (Table 4.8), which shown the size of the defect (depth and diameter) on each welds in relation with the figures of each joint, as in the figure shows the location of defect (see Fig 4.67 to Fig 4.72).

Fig 4.67 Welding defects on Billboard A (joint 1)

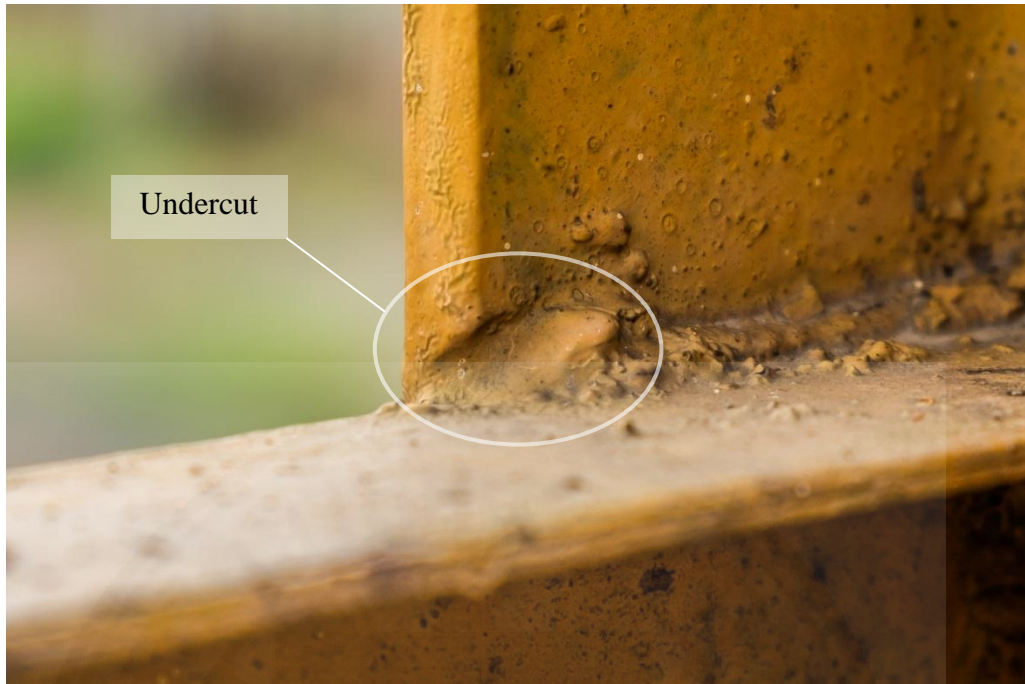
Fig 4.70 Welding defects on Billboard A (joint 4)

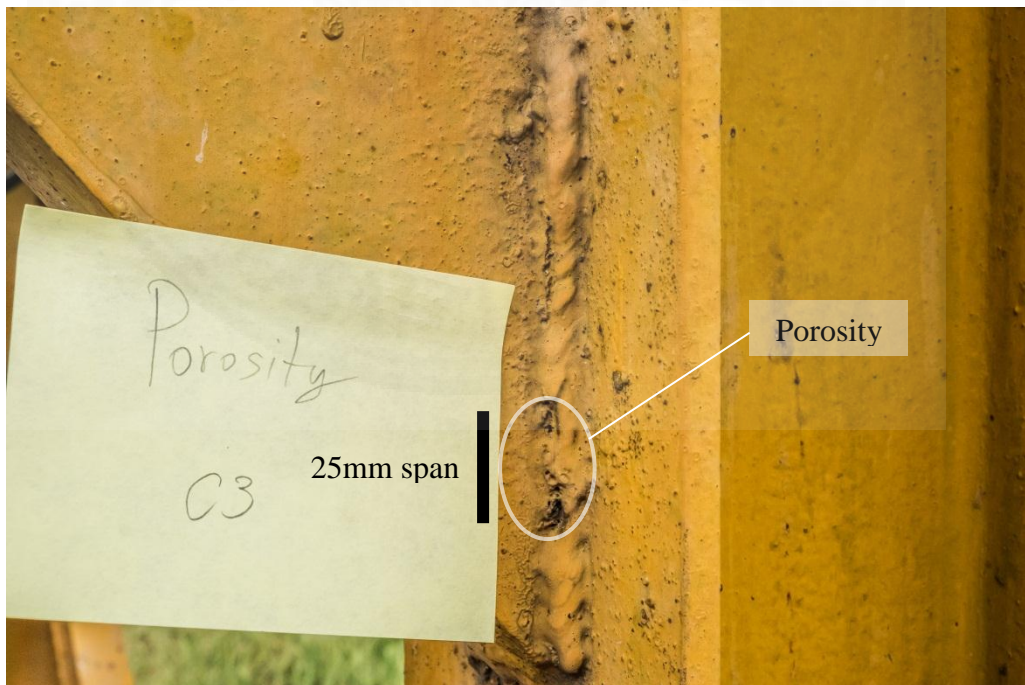
Fig 4.71 Welding defects on Billboard A (joint 5)

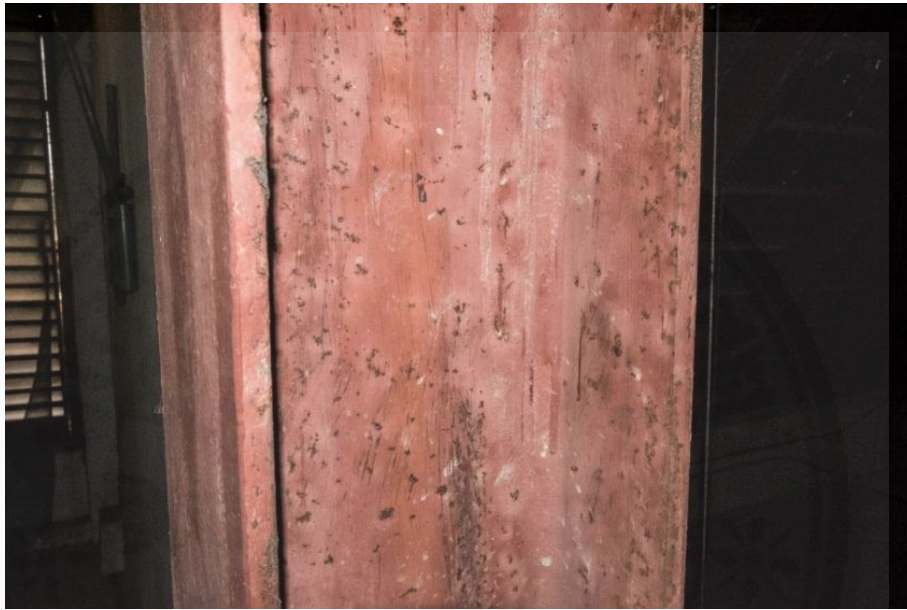
From Fig 4.74 to Fig 4.79 show the corrosion damage on the steel surfaces, and perceptible change in intensity of the steel coating.

Fig 4.74 Corrosion on the steel column at Roof Structure A (1)

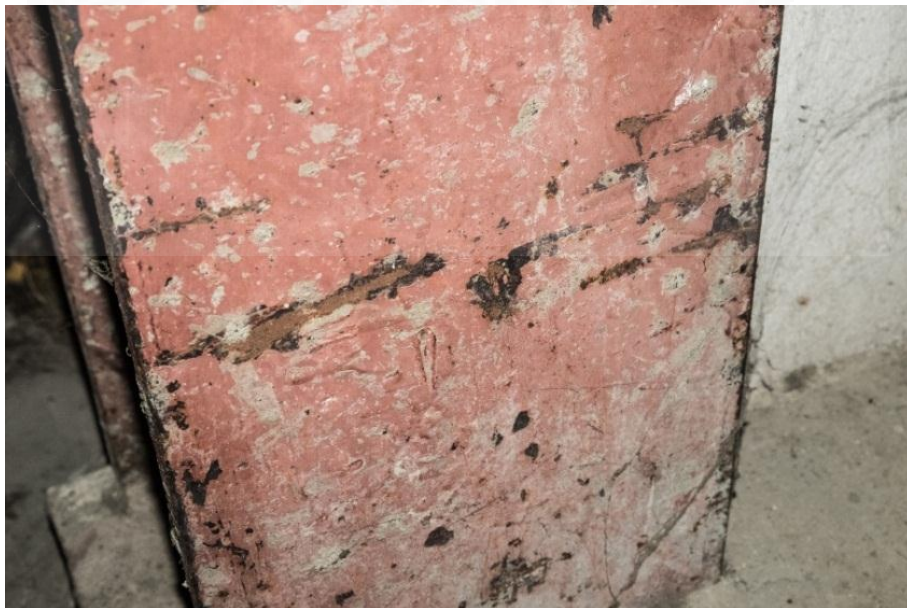
Fig 4.75 Corrosion on the steel column at Roof Structure A (2)

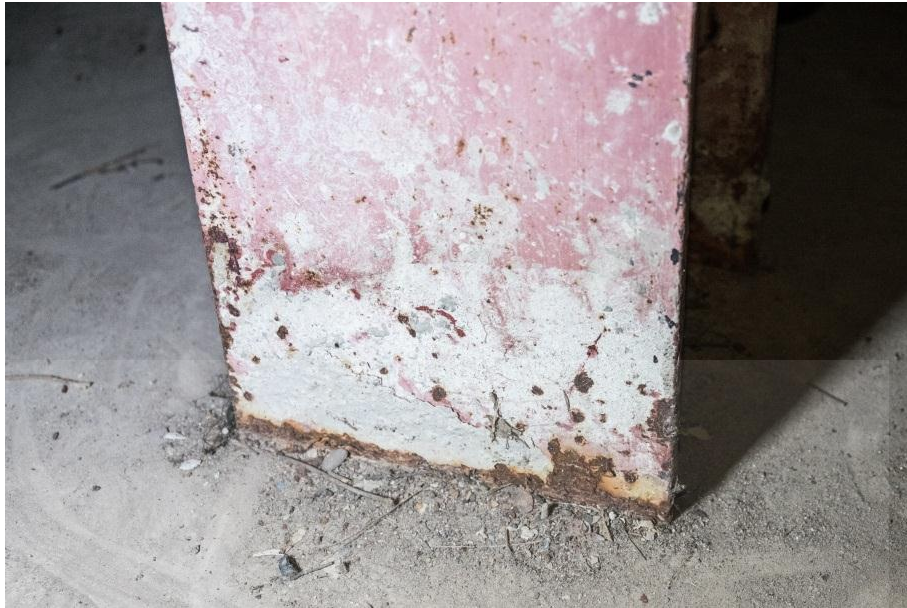
Fig 4.76 Corrosion on the steel column at Roof Structure A (3)

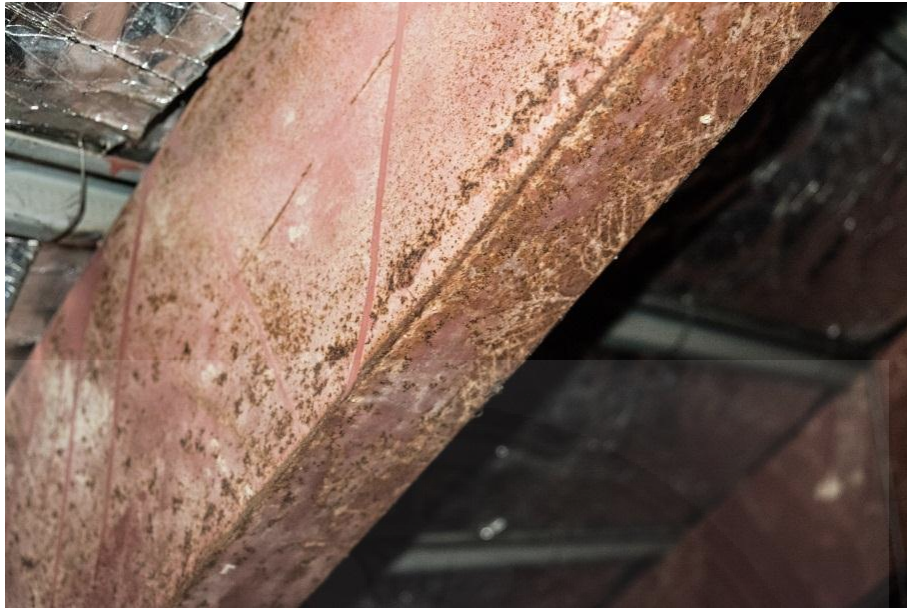
Fig 4.78 Corrosion on the steel beam at Roof Structure A

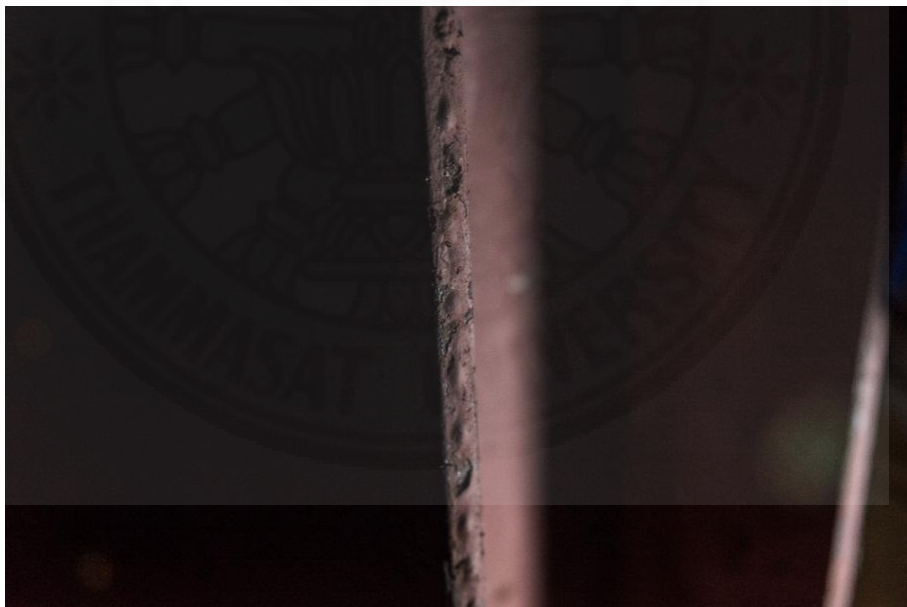
Fig 4.79 Blistering of paint on steel column at Roof Structure A

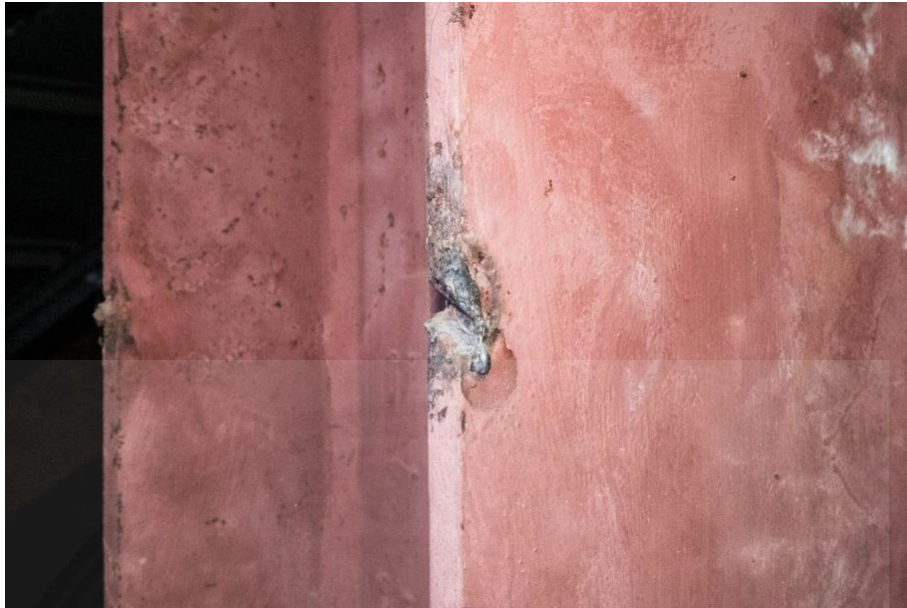
The inspection results show the damage from the welding process during the construction, the arc of the weld was melted the steel section out and penetrated the steel section as shown in Fig 4.80 to Fig 4.82. This type of damage came from poor workmanship of the welder.

Fig 4.80 Damage from welding process on the steel column (1)

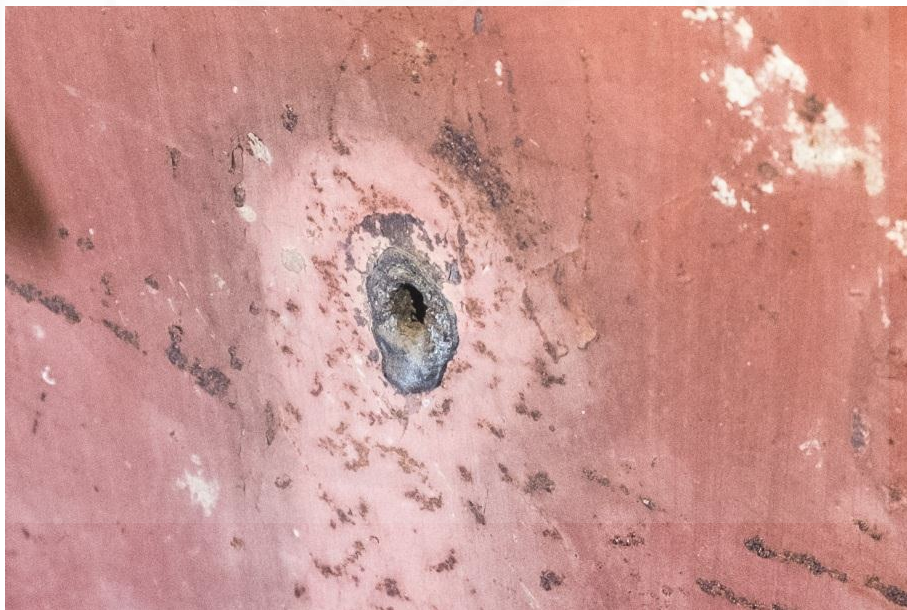
Fig 4.81 Damage from welding process on the steel column (2)

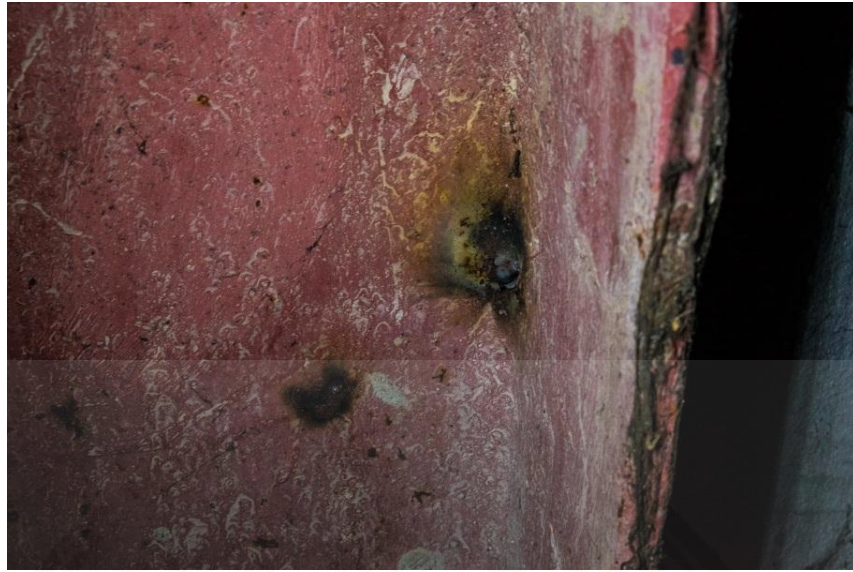
Fig 4.82 Damage from welding process on the steel column (3)

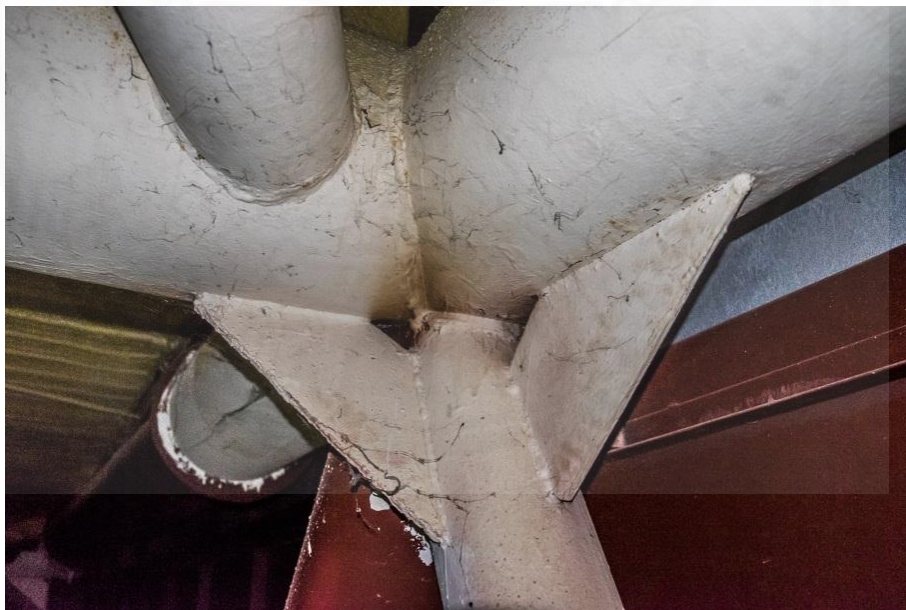
The steel coating has no damage at all, only a slight change in intensity of appearance (color) as shown in Fig 4.86.

Fig 4.86 Intensity change of steel coating at Roof Structure B

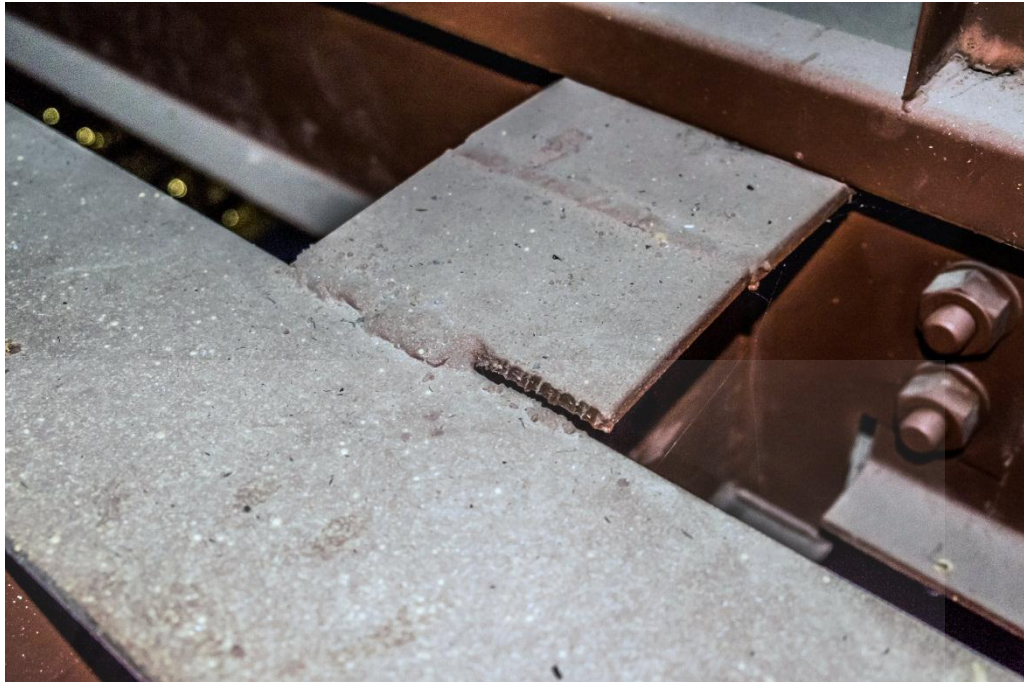
Fig 4.91 Missing weld on the beam girder at Roof Structure B
