**STUDY ON INSPECTION AND EVALUATION OF  
DAMAGED STEEL STRUCTURE IN THAILAND**

**A THESIS SUBMITTED IN PARTIAL FULFILLMENT OF THE  
REQUIREMENTS FOR THE DEGREE OF MASTER OF SCIENCE  
(ENGINEERING AND TECHNOLOGY)**

**SIRINDHORN INTERNATIONAL INSTITUTE OF TECHNOLOGY**

**ACADEMIC YEAR 2015**

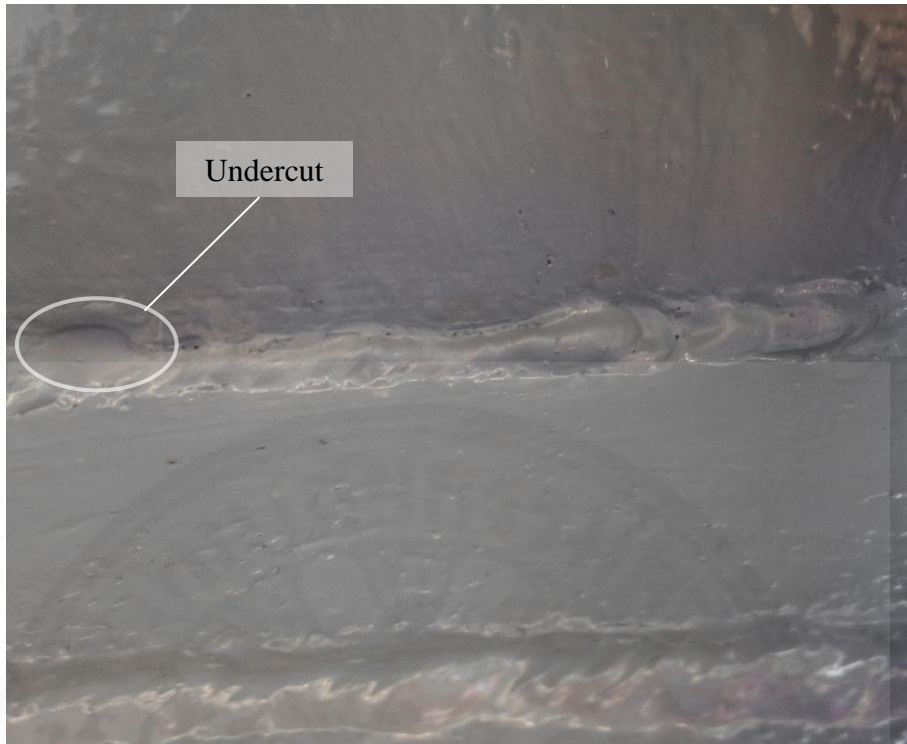
The inspection results show many weld defects mainly porosities and undercuts at the welding, the inspection results was recorded in the form of table (Table 4.10), which shows the size of the defect (depth and diameter) on each welds in relation with the figures of each joint, as in the figure shows the location of defect (see Fig 4.94 to Fig 4.101).

Fig 4.94 Welding defects on Steel Structure A (joint 1)

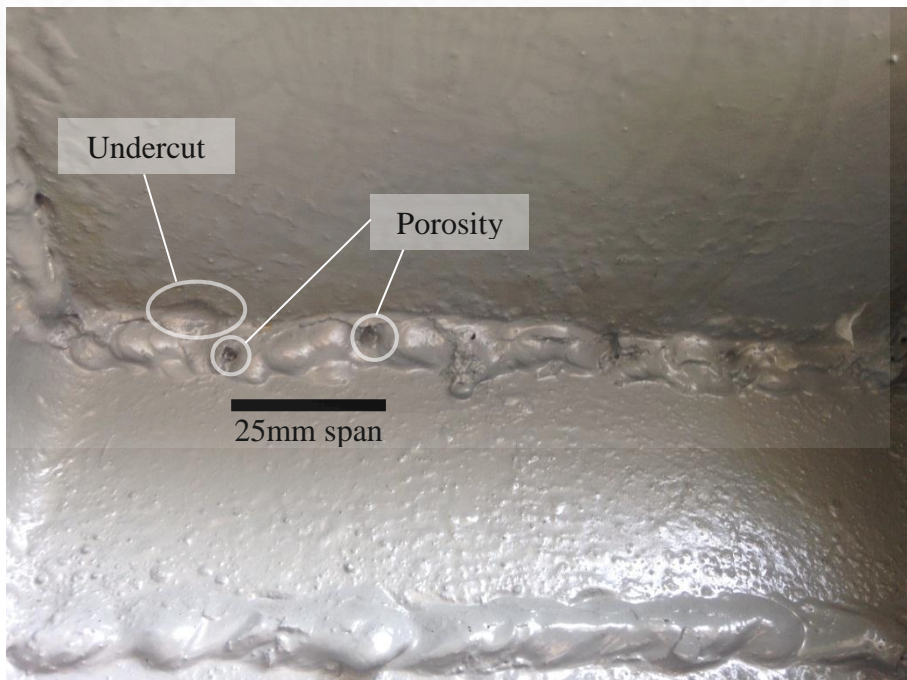
Fig 4.95 Welding defects on Steel Structure A (joint 2)

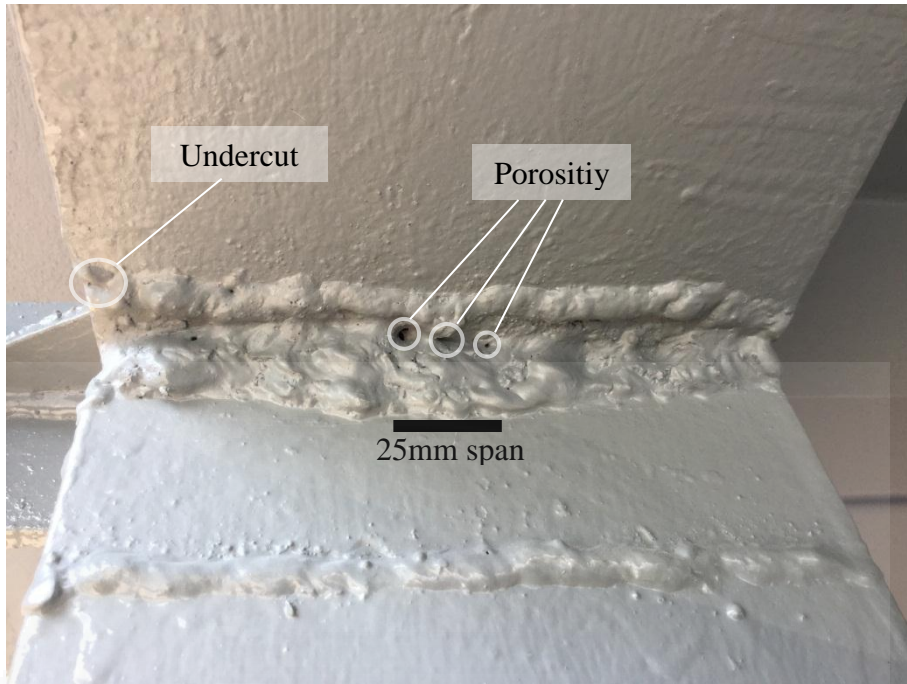
Fig 4.96 Welding defects on Steel Structure A (joint 3)

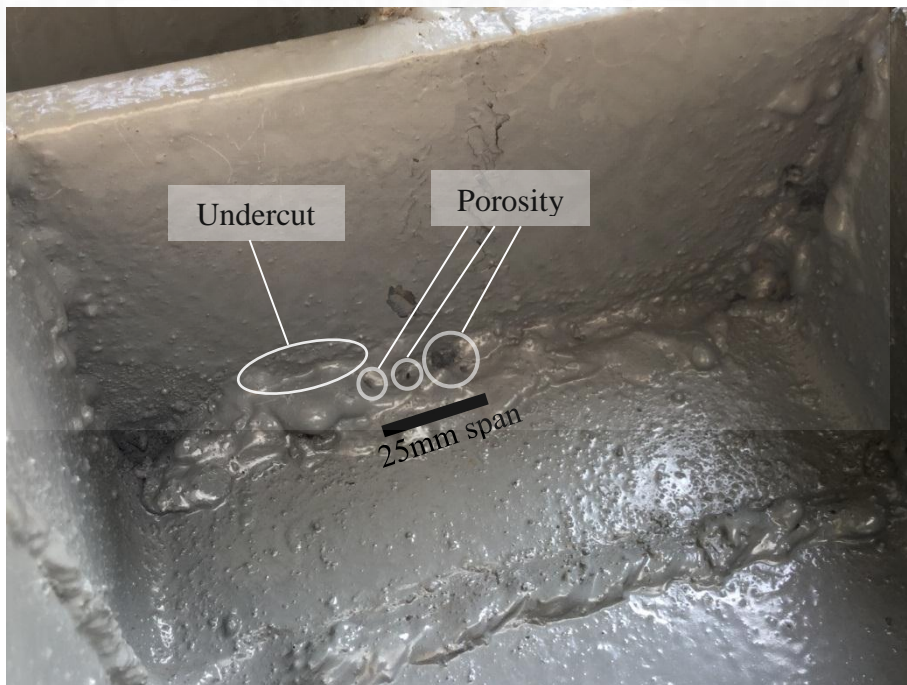
Fig 4.97 Welding defects on Steel Structure A (joint 4)

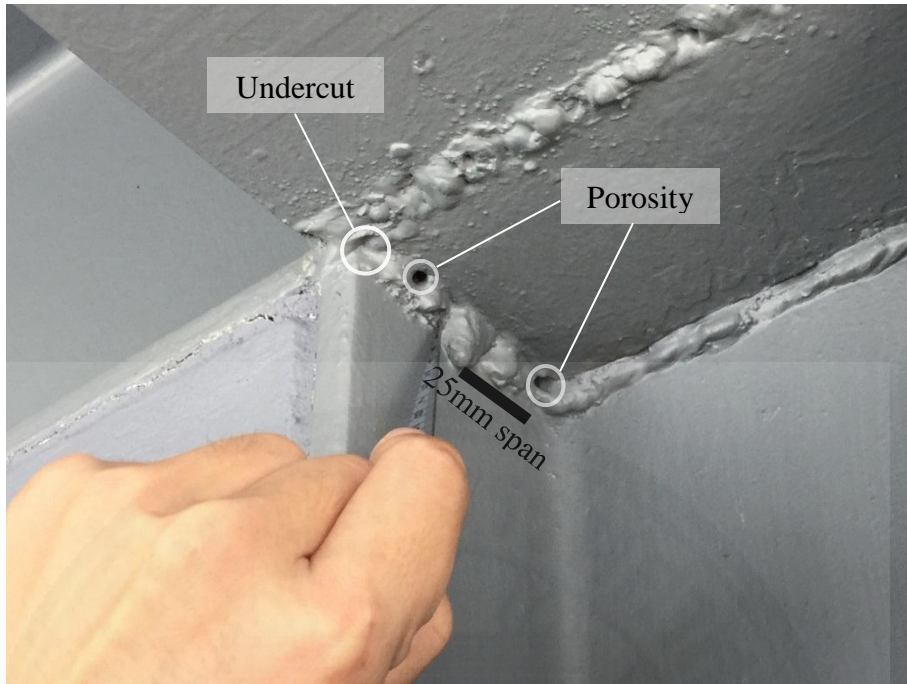
Fig 4.98 Welding defects on Steel Structure A (joint 5)

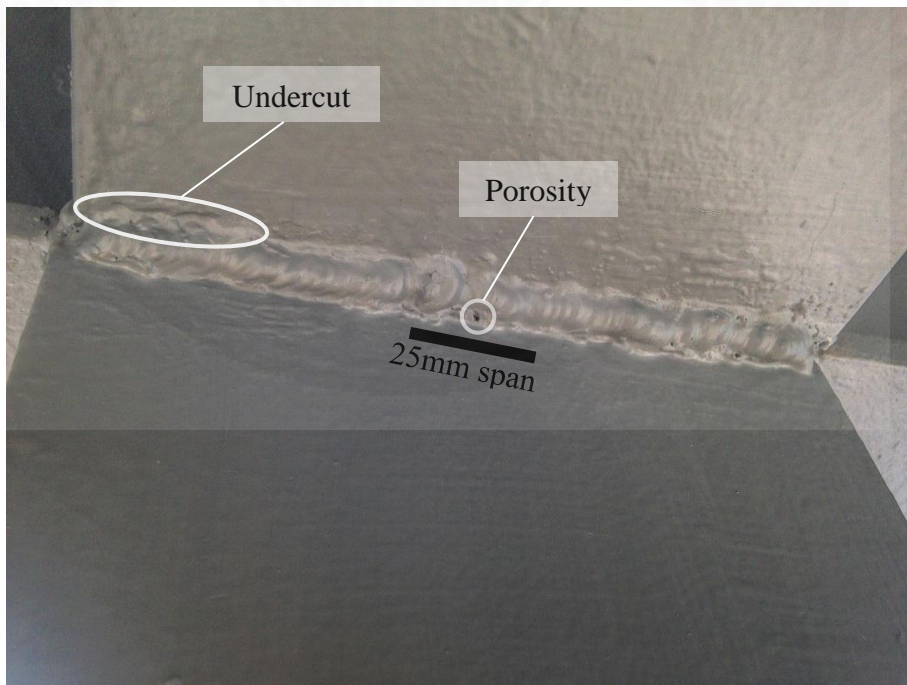
Fig 4.99 Welding defects on Steel Structure A (joint 6)

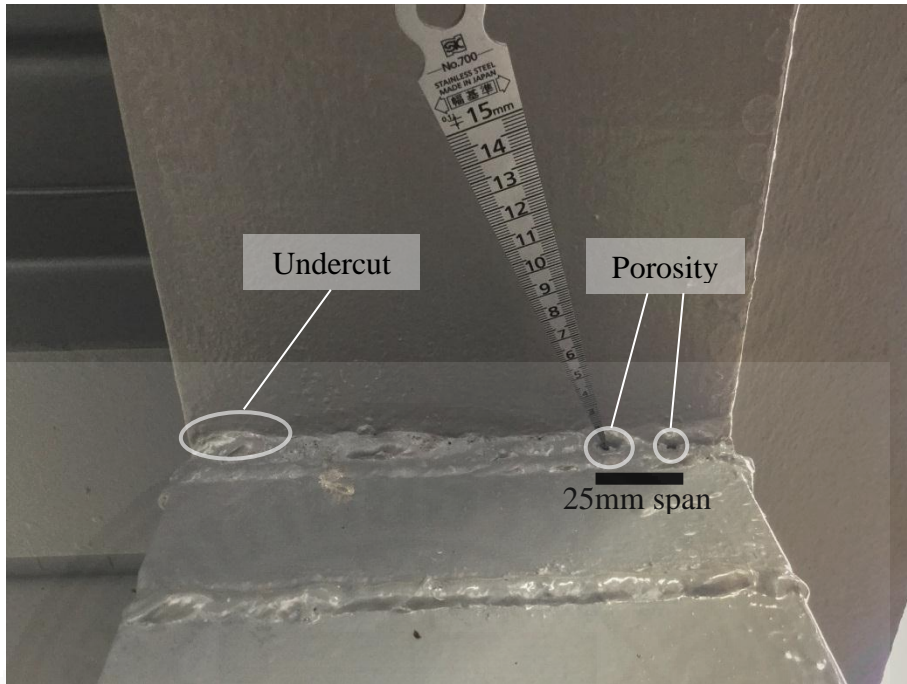
Fig 4.100 Welding defects on Steel Structure A (joint 7)

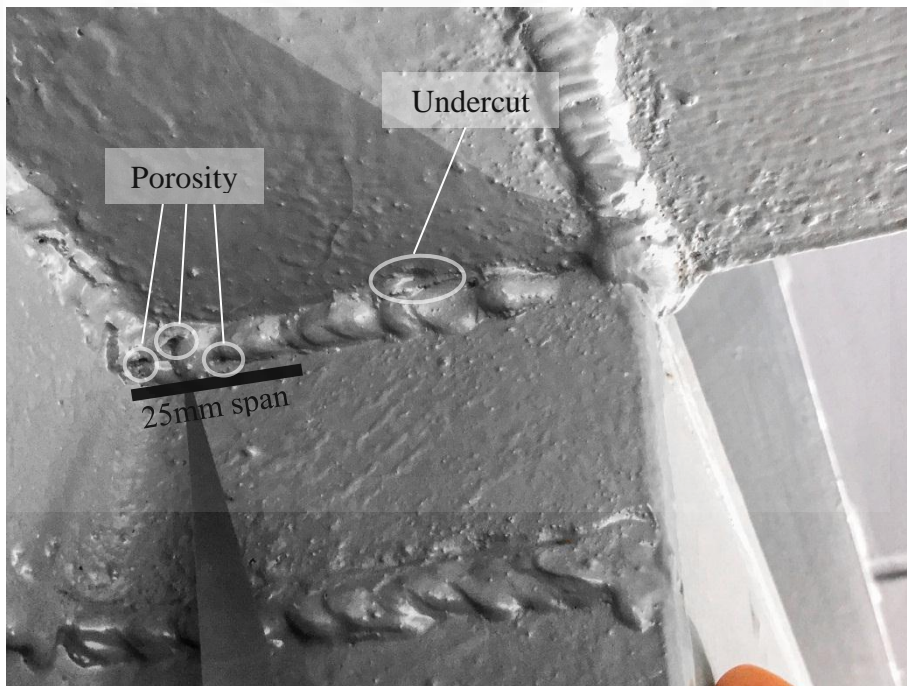
Fig 4.101 Welding defects on Steel Structure A (joint 8)

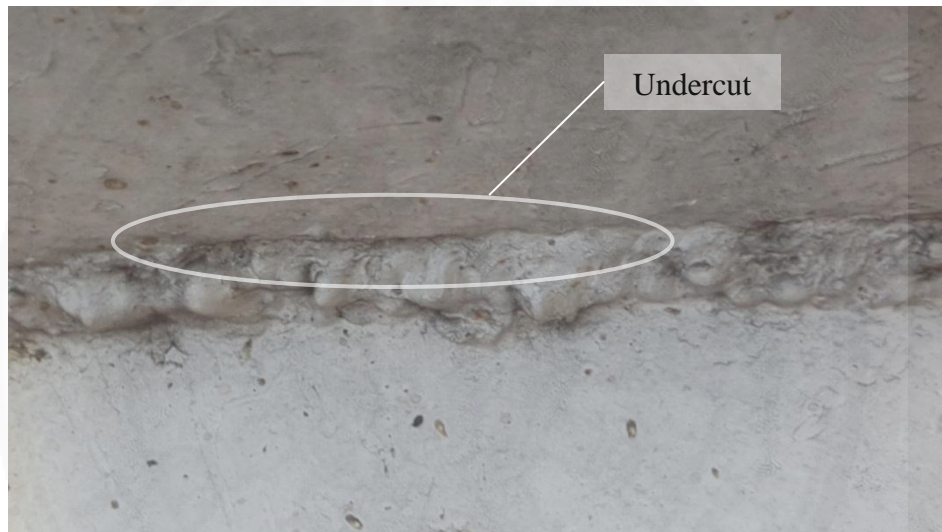
The inspection results show many weld defects mainly undercuts at the welding, the results was recorded in the form of table (Table 4.11), which shows the size of the defect (depth and diameter) on each welds in relation with the figures of each joint, as in the figure shows the location of defect (see Fig 4.103 to Fig 4.109).

Fig 4.103 Welding defects on Steel Structure B (joint 1)

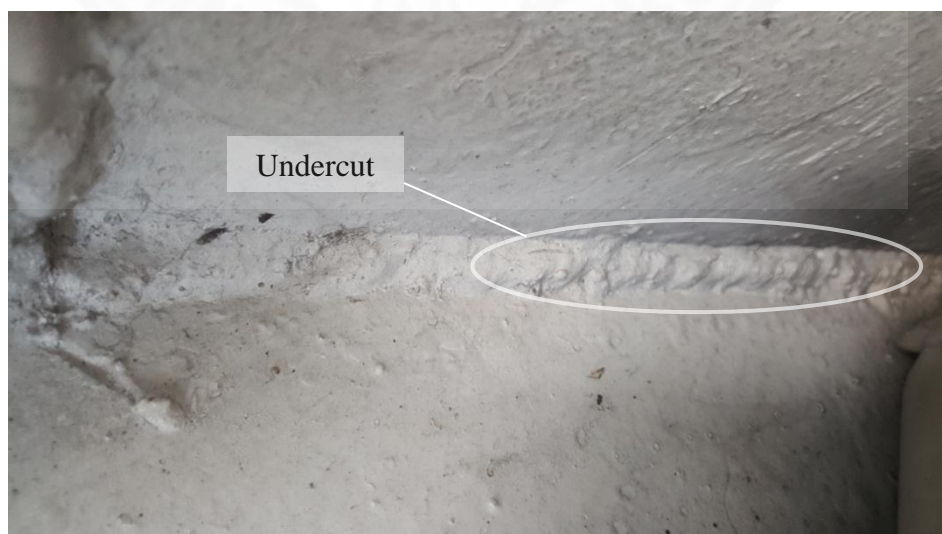
Fig 4.104 Welding defects on Steel Structure B (joint 2)

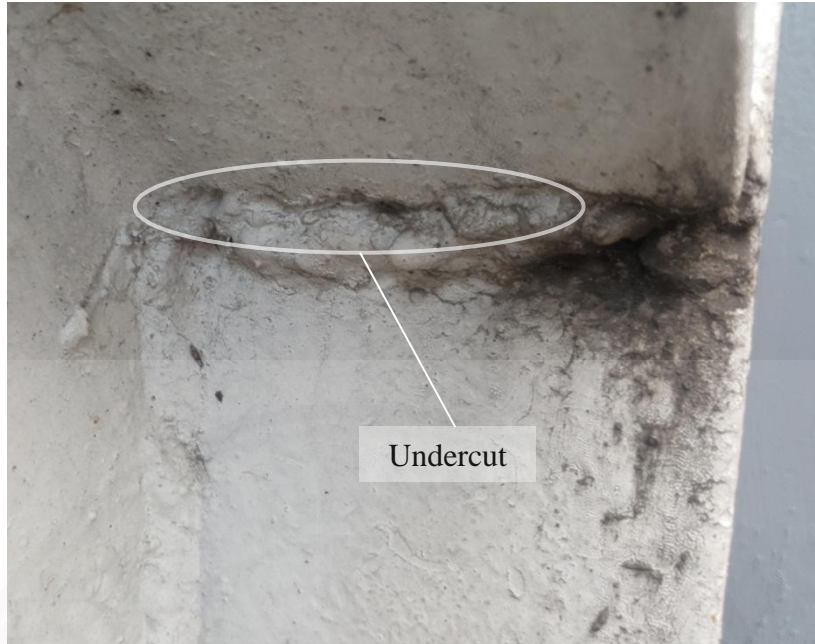
Fig 4.105 Welding defects on Steel Structure B (joint 3)

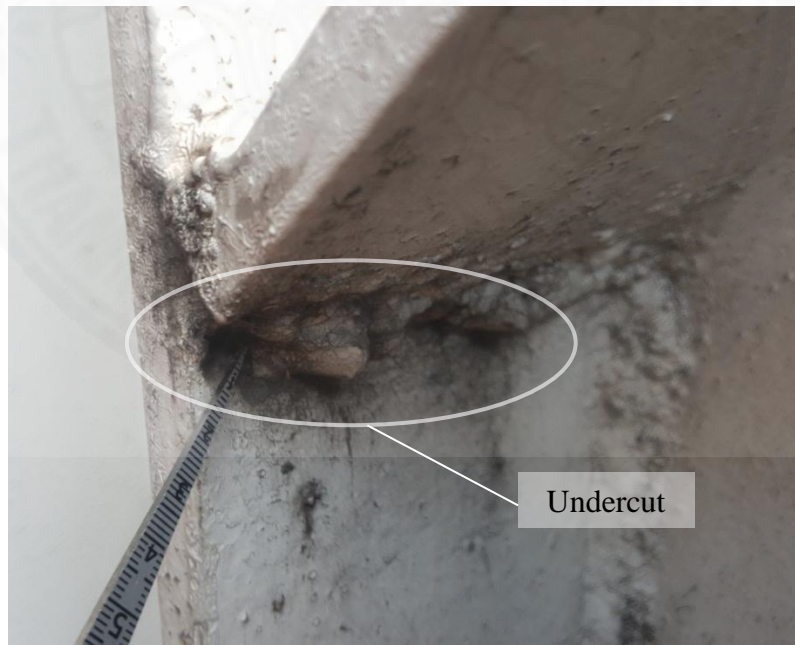
Fig 4.106 Welding defects on Steel Structure B (joint 4)
