**DEVELOPMENT OF STRUCTURE AND PAVEMENT
INSPECTION USING MOBILE LASER SCANNING
POINT CLOUDS: A CASE STUDY OF THAILAND
EXPRESSWAY**

**A DISSERTATION SUBMITTED IN PARTIAL FULFILLMENT
OF THE REQUIREMENTS FOR THE DEGREE OF DOCTOR
OF PHILOSOPHY (ENGINEERING AND TECHNOLOGY)
SIRINDHORN INTERNATIONAL INSTITUTE OF TECHNOLOGY
THAMMASAT UNIVERSITY
ACADEMIC YEAR 2022**

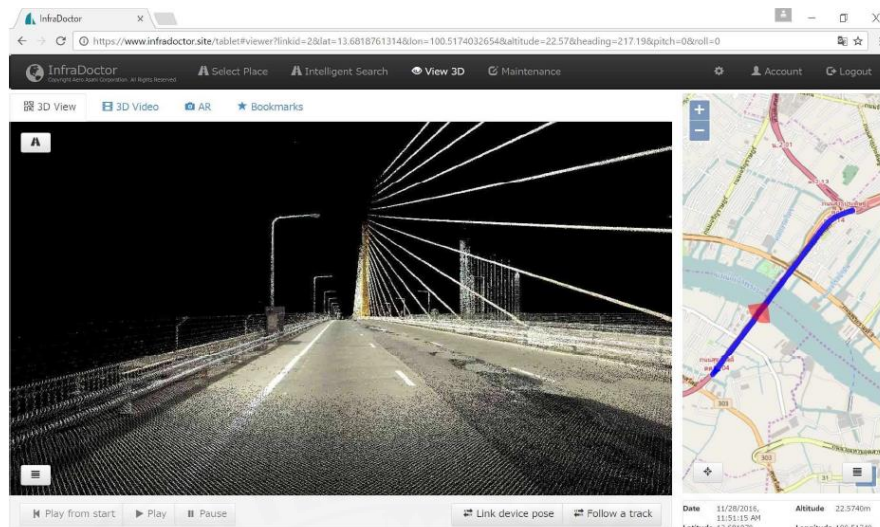
Figure 1.2 InfraDoctor Web Page

The InfraDoctor is a web-based application for expressway asset management as shown in **Figure 1.2**. The content of the website is 3D point cloud data of expressway and related documents such as drawings, inspection reports and so on. Final development of the website is online-asset database which contain all information of structure history on GIS platform.

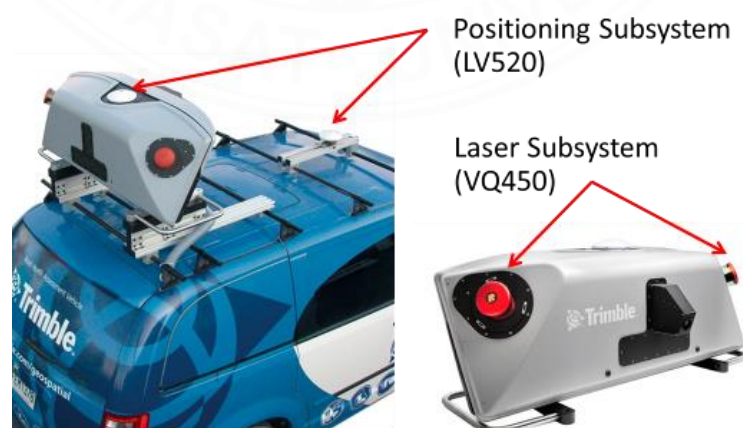
Figure 1.3 Mobile Mapping 3D Laser Scanner (MLS)

The main part of the InfraDoctor is 3D point cloud data of structures. The point cloud data is created from Mobile Mapping 3D Laser Scanner (MLS). MLS is a vehicle equipped with 360° laser scanners, cameras, GPS antennas and data loggers, as shown in **Figure 1.3**. The scanning is performed during driving such that long distances can be scanned quickly. Structures along roadside, especially viaduct structure are scanned conveniently. Scanning results can be used for structure inspection. This can overcome the limitations of the visual inspection which will be helpful for expressway inspection.

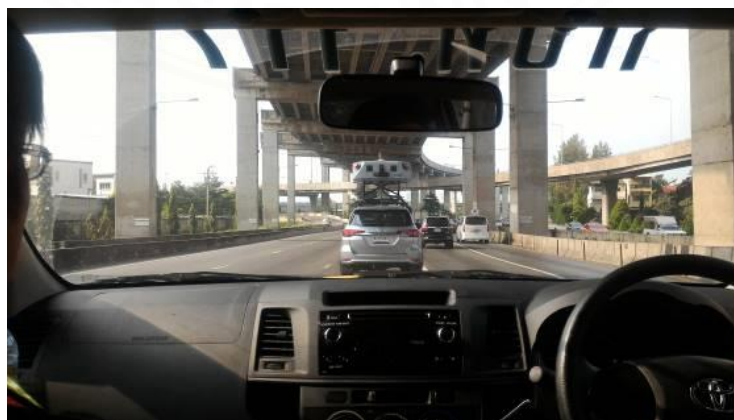
Figure 3.1 MLS while scanning

On expressway, MLS measurement range was set to 100 m with measurement rate of 0.5 MHz per laser head. Data was acquired at 1 million points per second. The machine preparation took around 20 minutes waiting for GNSS signal. MLS moving speed can be up to 80 km/h. A shadow car was provided by 5 m-6 m interval to prevent another vehicle cutting the scanning line. However, due to safety concerns, the measurement was done at a speed of about 40 km/hr. During the measurement, neither sound nor light is noticed. Just like the other car is running on expressway as shown in **Figure 3.1**. After 2-3 hours of measurement, the MLS was paused to cool down.

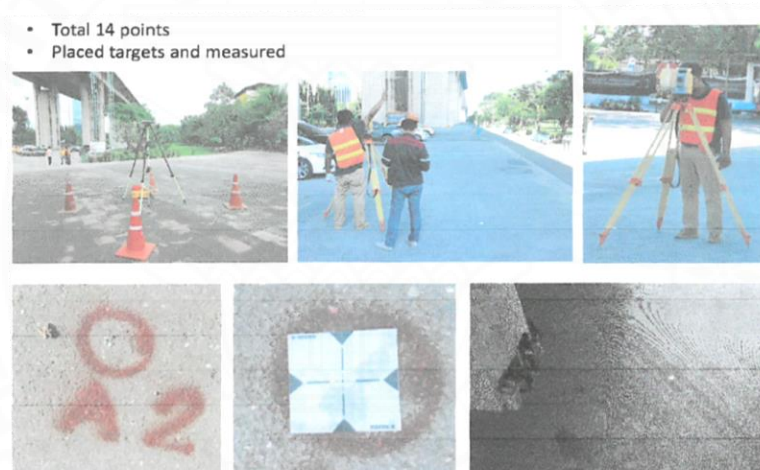
Figure 3.2 Point cloud data rectification

Point cloud data was prepared by the machine operator (AERO Ashi Corporation). Global coordinate was rectified with known coordinates, as shown in **Figure 3.2**. Unwanted points such as noise and irrelevant objects such as vehicles or humans were removed. The resulting data was in the form of point cloud image of pavement and expressway structure without any vehicle as shown in **Figure 3.3**. Two-km of road scanning produced about 33.5 GB of data. So, enough storage should be prepared in advance. The data were ready for further action.

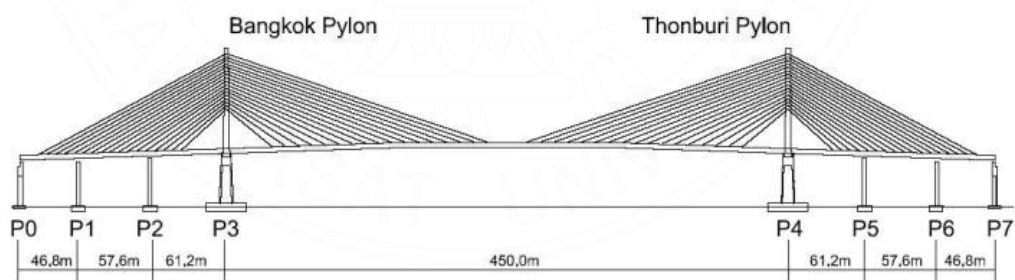
Figure 3.5 The Rama IX Bridge Elevation

The Rama IX Bridge crosses the Chao Phraya River to link the eastern and western sides of Bangkok. This 30-year-old bridge is a single plane symmetric cable-stayed bridge carrying six lanes of traffic, with a total length of 782 meters and composed of a clear span of 450 meters and two side spans of 166 meters each, as shown in **Figure 3.5**.

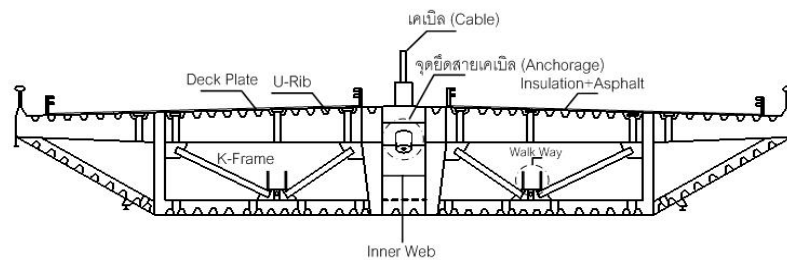
Figure 3.6 Deck cross section

Bridge deck was a three-cell steel box girder, 33 meters wide, and 4 meters deep at the centre, as shown in **Figure 3.6**. Asphaltic surface provides for traction and wearing resistance on the top plate.

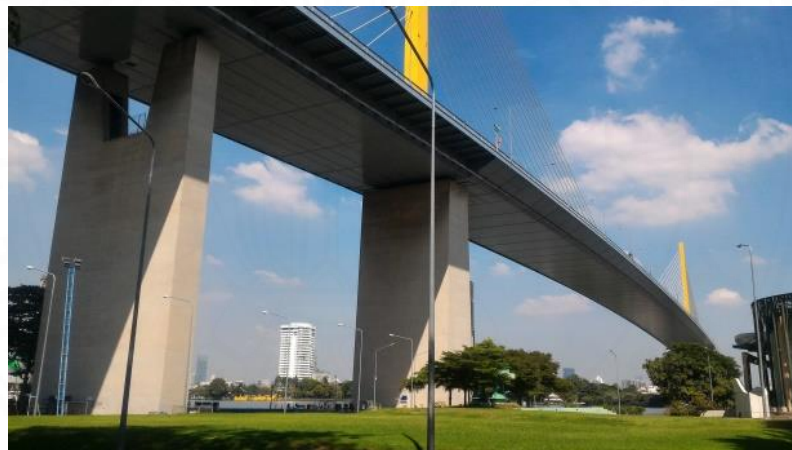
Figure 3.7 The Rama IX Bridge, Bangkok, Thailand

The 87-meter-tall pylons pass through the bridge deck on the top of concrete piers. The steel pylons are closed rectangular boxes with additional internal framing to carry the cable anchorages. The piers that support the pylons have hollow concrete sections. The appearance of the bridge is shown in **Figure 3.7**.

The bridge geometries such as deck profile and pylon top movement shall be regularly measured according to bridge inspection manual. The manual stated that the movement should not larger than span/1000. Thus, deflection of 450 m main span should not greater than 450 mm. The lateral movement on the top of pylon should not be larger than 87 mm. Normally, movement is measured by total station. Only 5 points on bridge deck were measured in 2001 and 34 points on the bridge were measured in 2012 while pylon top movement has never been checked. The better measurement technique is expected to examine bridge geometry change.

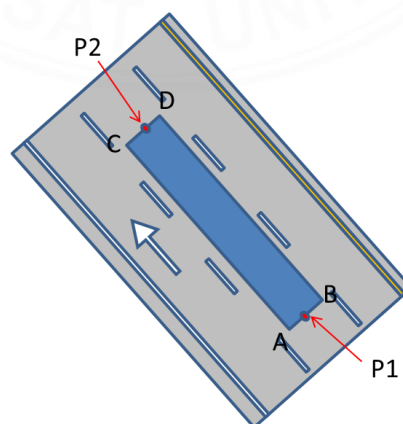
Figure 3.10 Crop area A-B-C-D for segmentation

Second Step: “Input file” is generated from MATLAB. GPS data from profilometer, point P1 and P2, were used to create “Crop area” (Area A-B-C-D in **Figure 3.10**). Width of the cropped area (A-B) can be set between 3.0 m - 3.5 m depending on lane width. In this case, width was set to 3.0 m. Length of the cropped area was dependent on distance between points P1 and P2. So, the cropped area was 3.0 m x 25.0 m, according to profilometer GPS data. Then, point cloud only in the “Crop area” were selected. One section of the road was 3.0 m x 25.0 m having around 144,000 points. Point density was about 1,900 points/square meter.

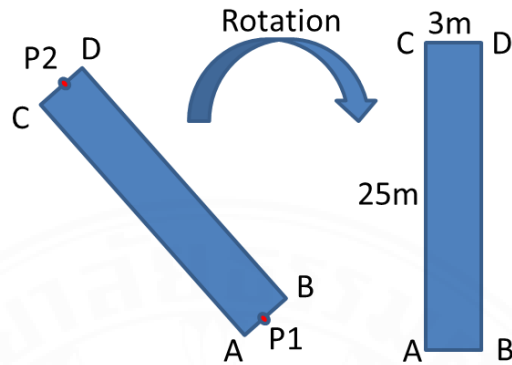
Figure 3.11 Cropped area Rotation

Third Step: Rotate data in cropped area to perpendicular direction for ease of meshing, as shown in **Figure 3.11**

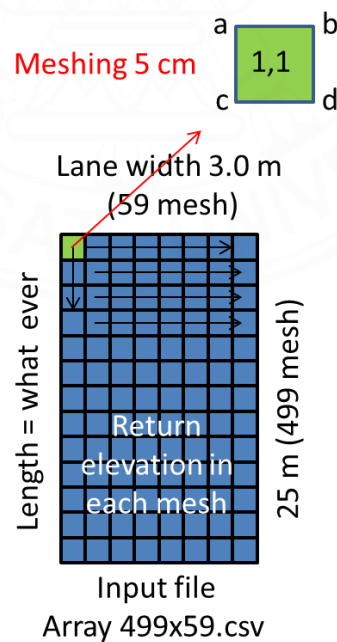
Figure 3.12 Cropped area meshing

Forth Step: Mesh the cropped area into small pieces. The smallest mesh size was 5 cm. Mesh area (area a-b-c-d) was created, as shown in **Figure 3.12**. Then, point cloud in the meshed area was selected and their elevation (z) was returned. An average elevation of points was representative elevation in mesh [1,1]

Point density was about 1,900 points/sq.m. Mesh area of 5 cm x 5 cm had 4.82 points in average. There are enough points to estimate the average elevation. Once mesh [1,1] was finished, the same process moved forward to mesh [2,1] by a loop operation. Finally, cropped area of 3.0 m x 25.0 m was operated having 59 x 499 mesh (5 cm mesh). Then, a file with name of “inputfile.m” was created. This file was an array of 59x499 and was ready to be executed in “Pavement inspection program”.

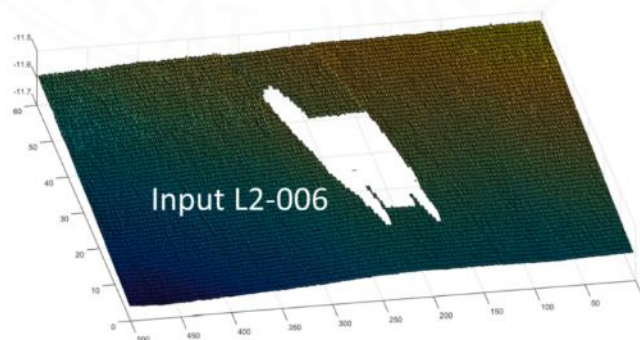
Figure 3.14 large blank element inputfile

Fifth Step: The “inputfile.m” must not have blank elements. This can happen because of blank point cloud data (in some area). Small area of blank element can be fixed by using elevation of the neighbouring elements. For large area of blank element, input data was considered incomplete and rejected.

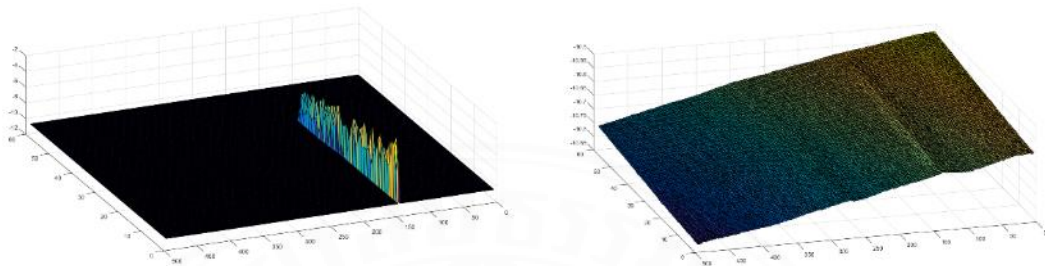
Figure 3.15 Corrupted and corrected “inputfile”

In some cases, “inputfile” was corrupted by non-pavement point cloud data. Therefore, corrections were needed to be done.

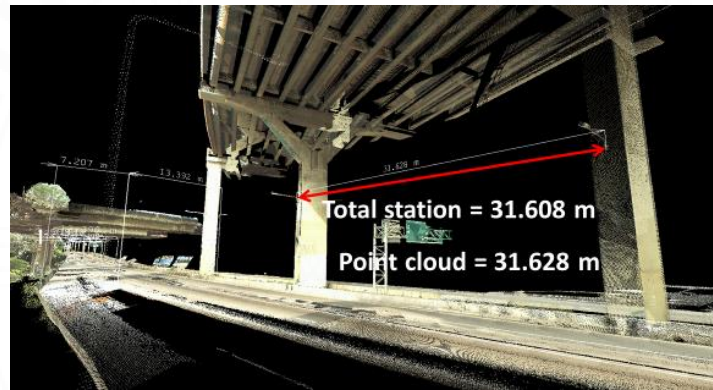
Figure 4.1 Distance comparison

A total station (Topcon ES-105 model) was used to validate the dimension. The Topcon could measure the distance up to 500 m with the accuracy of ± 3 mm. Distances between some arbitrary points were measured using the total station and compared to the distance measured by point cloud, as shown in **Figure 4.1**. The comparison is shown in **Table 4.1**.

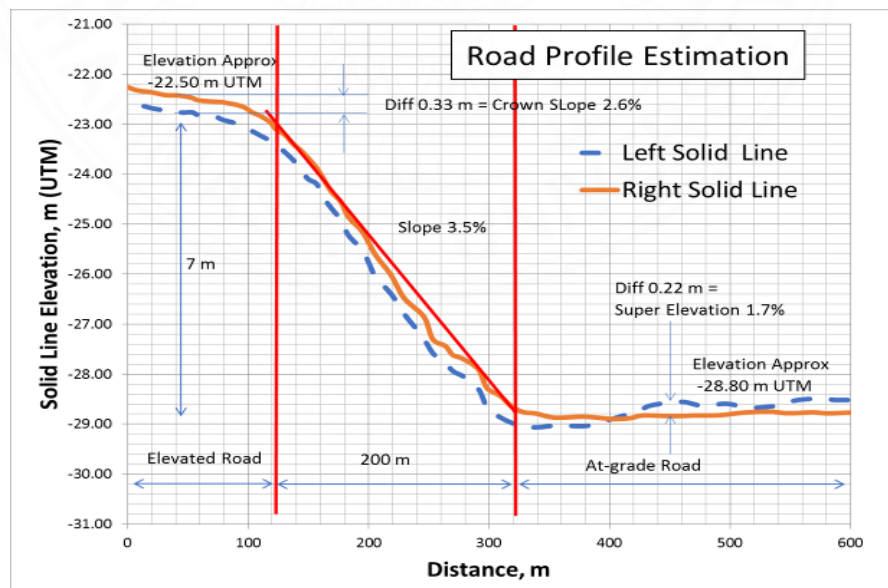
Figure 4.2 Road profile measurement

Topography comprises not only road width or column height but also road elevation and road gradient. Road profile was extracted from point cloud data as well. Elevation (in UTM) along left and right of the solid line was plotted against distance. It was found that the road is elevated for 6.3 m with 3.5% of slope gradient as shown in **Figure 4.2**. The gradient was found to confirm with the drawings. Additionally, crown slope and super elevation was also acquired. The measured crown slope was 2.6%, which is considered slightly high comparing to the standard value of 2.5%. The super elevation was about 1.7%. This is also considered high comparing to the maximum value of 1.5%. Although crown slope and super elevation are not considered for the traffic modelling, they are useful for drainage design and clearance check.

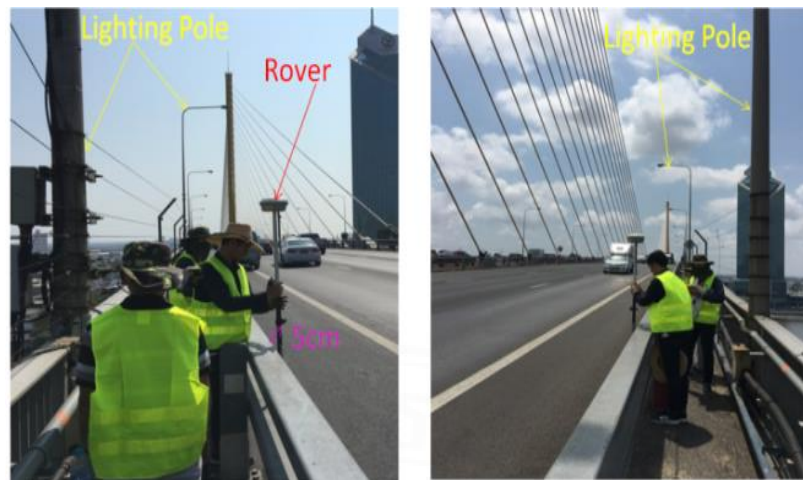
Figure 4.4 RTK survey.

Real time kinematic survey, RTK (South S82T model) was used to validate the point cloud data. By specifications, the horizontal accuracy was ± 8 mm. The vertical accuracy was ± 15 mm. Elevations were measured by the RTK for 66 points as shown in **Figure 4.4** (Left: 20 points, Right: 20 Points, Centre: 24 points and each 1 on top of each pylon).

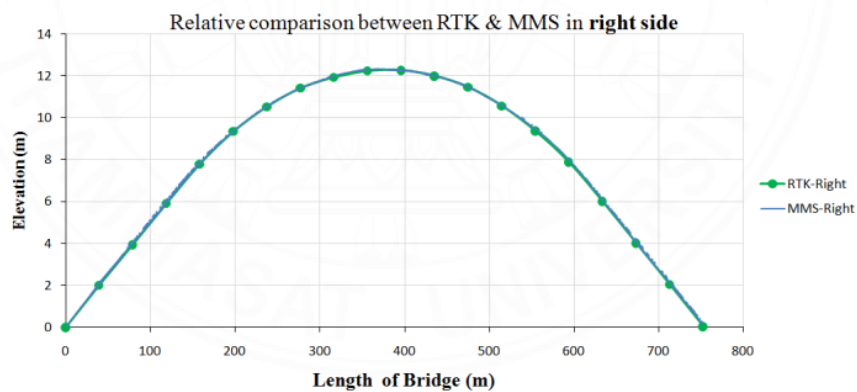
Figure 4.5 Elevations between RTK & MLS

The bridge profile between MLS and RTK survey are plotted together, as shown in **Figure 4.5**. Elevations measured by point cloud matched well to the elevations measured by RTK. This examination provided a high confidence on point cloud data for further assessments.

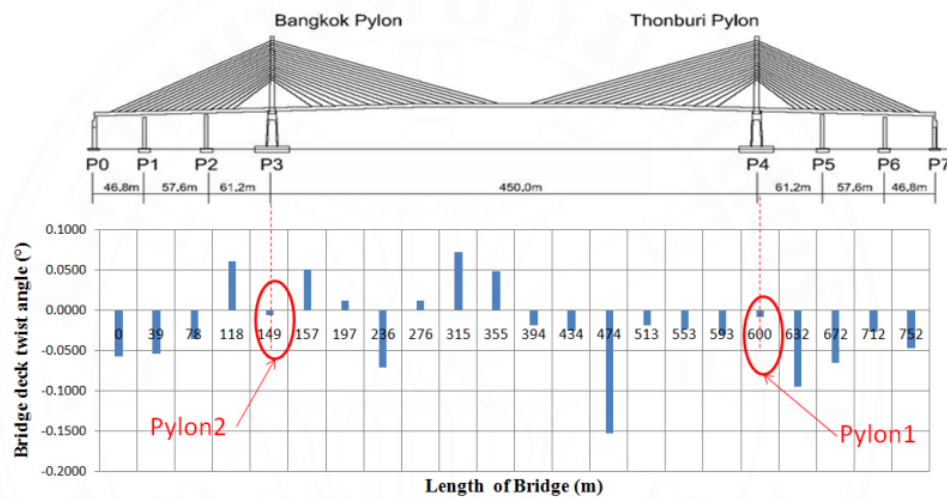
Figure 4.6 Twist angle along bridge length

mm) and elevation measurement accuracy (± 15 mm), twist angle measurement of $\pm 0.05^\circ$ was possible assuming that the deck was perfectly horizontal. The results show that most of the measured twist angles were within the threshold (i.e., $\pm 0.05^\circ$) as shown in **Figure 4.6**. Angles at the pylons were low as expected. Twist happened in both directions, clockwise and counter clockwise. It can be concluded that, no sign of permanent twist was observed for the deck.

- From the point cloud data, bridge profile, twist angles of the deck, and lateral movements of pylons were assessed. The results showed that most of the measured twist angles were within the acceptable limits ($\pm 0.05^\circ$). No sign of a permanent twist was observed for the deck. The top movement of the west and east pylon was 104 mm and 138 mm, respectively. However, a periodic inspection was suggested due to the absence of initial readings of the pylon.

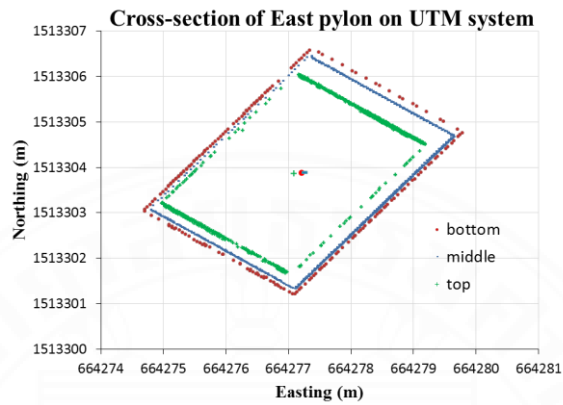
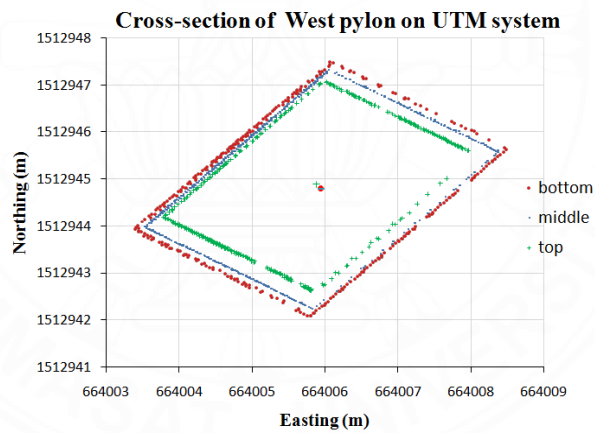
These values are larger than the maximum value stated in the inspection manual, but the original position just after the construction was not available. Therefore, a periodical monitoring was recommended.

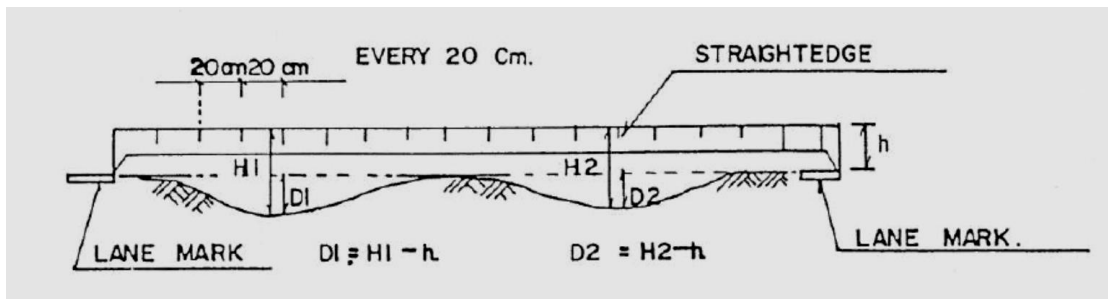
Figure 4.9 Straight Edge for rutting measurement

Change of pavement geometry, rutting, was measured by straight edge at an interval of 20 m. Rutting was defined by a bigger value between D1 and D2, as shown in **Figure 4.9**.

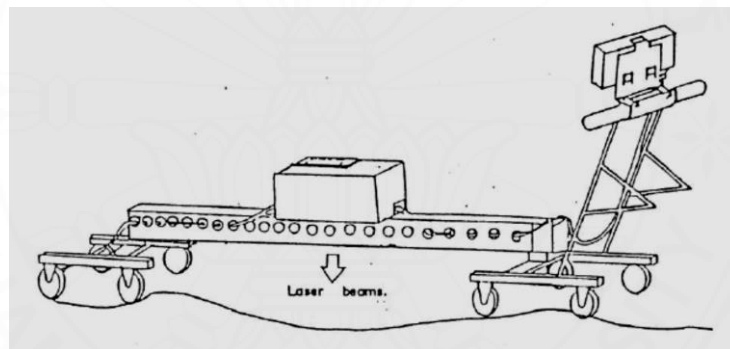
Figure 4.10 Laser Profilometer

Roughness and corrugation in the longitudinal direction were measured by laser profilometer. The meter was travelled along left wheel track for a distance of 100 m. The depth was measured by laser after every 1.5 m. Standard deviation of the depth was taken as longitudinal roughness, as shown in **Figure 4.10**.

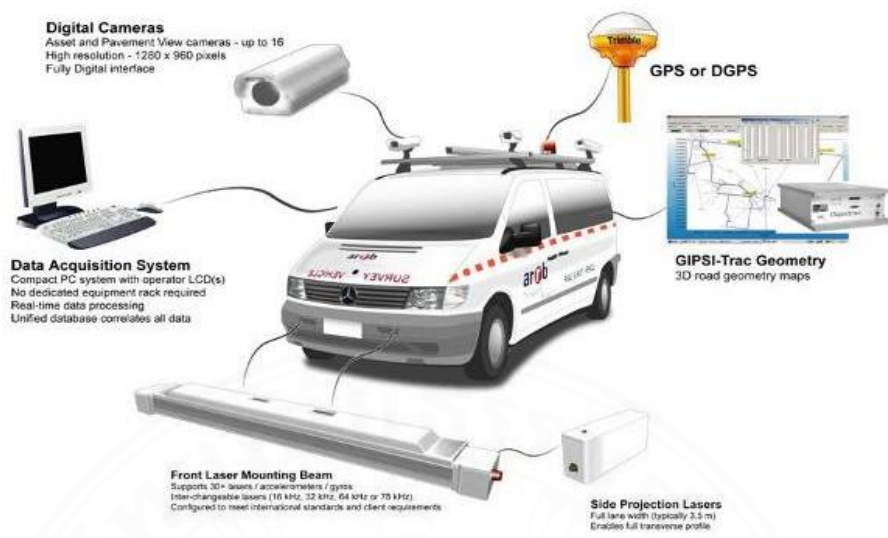
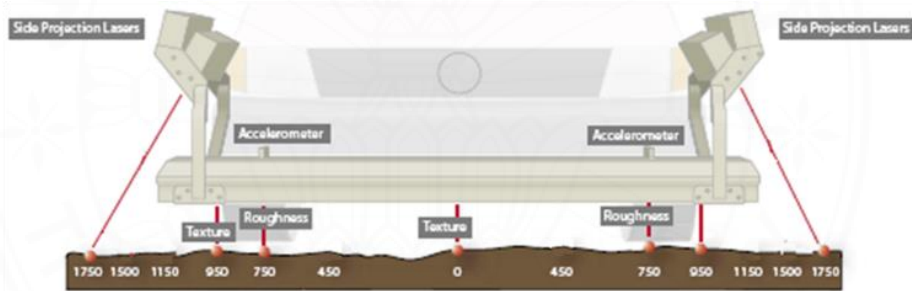
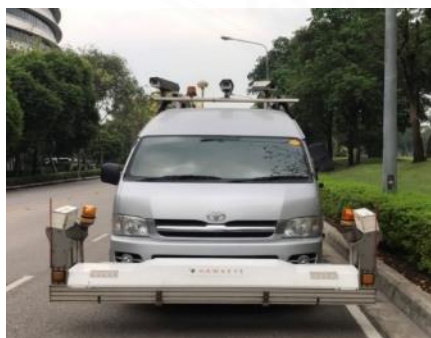
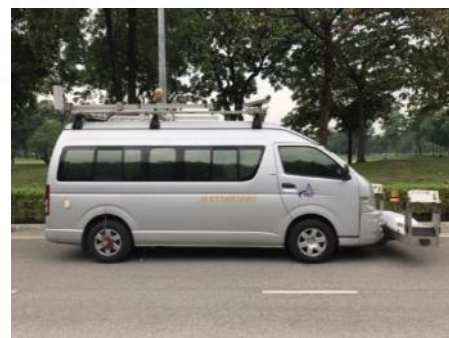
The latest one in 2019, EXAT utilized highway survey vehicle for collecting pavement survey data. The vehicle was equipped with a laser profilometer, video logging modules (5 cameras), distance measurement instrument (DMI), and GPS receivers, as shown in **Figure 4.11** **Figure 4.12** and **Figure 4.13**.

The vehicle collects distress data after every 25 m. International Roughness Index (IRI) and rutting were measured by profilometer. Cracks and other kind of distress are recorded by cameras. All collected data were referenced with GPS coordinates. Thresholds for IRI, rutting, and surface friction directed by EXAT is shown in **Table 4.3**

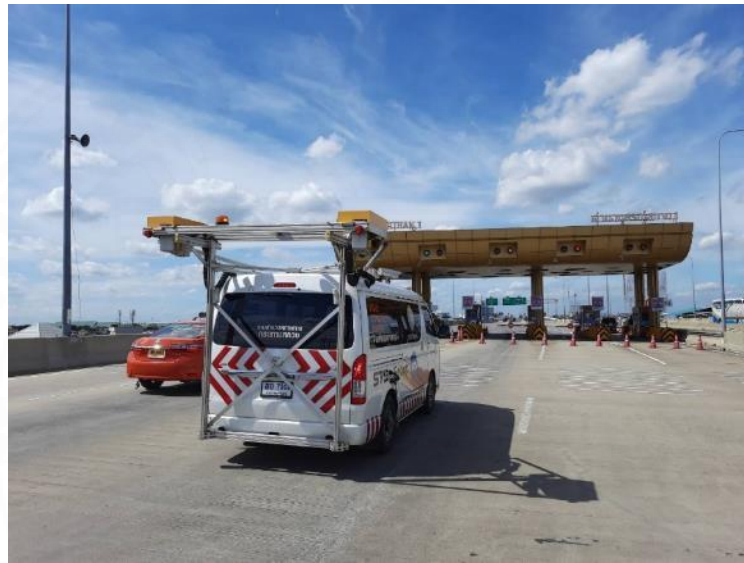
Figure 4.15 Laser crack measurement system

DMT perform pavement inspection in 2020. Pavement is measured for IRI and rutting by difference device. ROMDAS Laser crack measurement system (LCMS) from New Zealand is used as shown in **Figure 4.15**. LCMS is equipped with 2 laser line projectors from Pavemetrics™ and advanced optics to acquire high resolution 3D profile of the road surface.

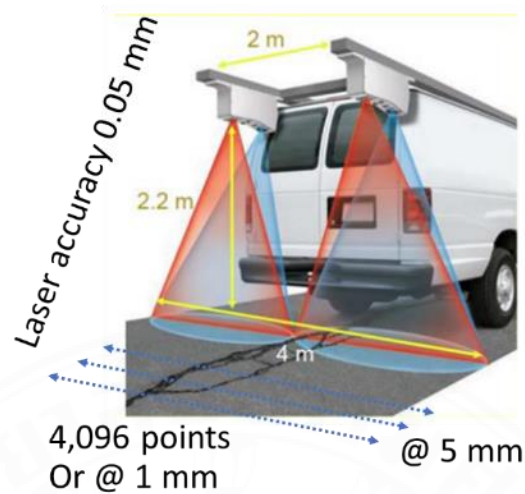
Figure 4.16 LCMS laser projection

Two laser projectors cover 4 m wide profile of pavement measurement. LCMS records 4096 points per profile as shown in **Figure 4.16**. So, pavement cracking down to 1 mm can be detected. Distance between each profile is 5 mm. As result, measurement resolution is 1x5 mm. In the area of 5x5 cm there will be 500 points of measurement. Survey speed can be up to 100 kmph.

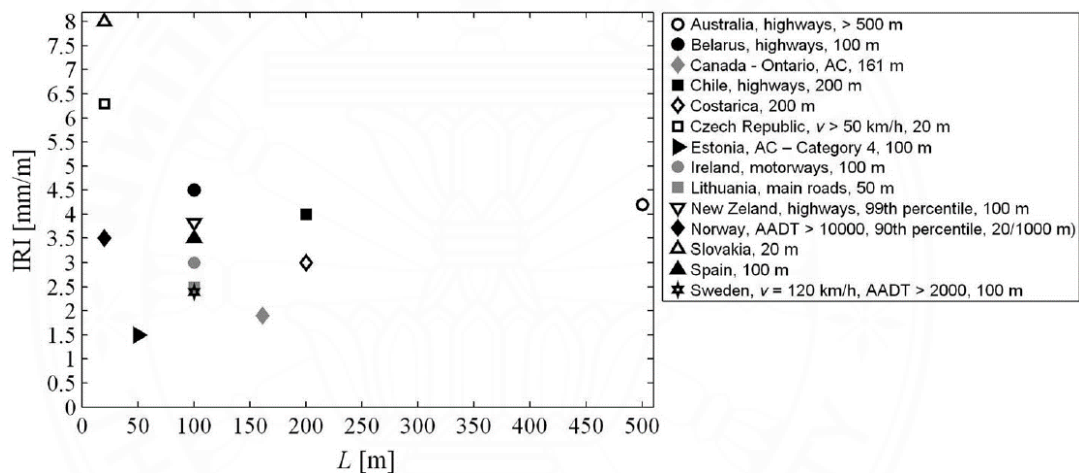
Figure 4.17 IRI and segment length in various countries

Each road agency performs their pavement assessment by difference machine. Method of measurement is also different. Even road length segment ranges from 1 m to 100 m in Thailand. Múčka (2017) reviewed IRI measurements around the world. Segment length ranged from 20, 50, 500, 161, 200 and more than 500 m. There were several types of machines utilized including inertial profilers and inclinometer-based devices. Measurement methods were also different including single profile, two longitudinal profiles, and more than two profiles. So, large differences in IRI limit were observed for the same segment length among various countries as shown in **Figure 4.17**.

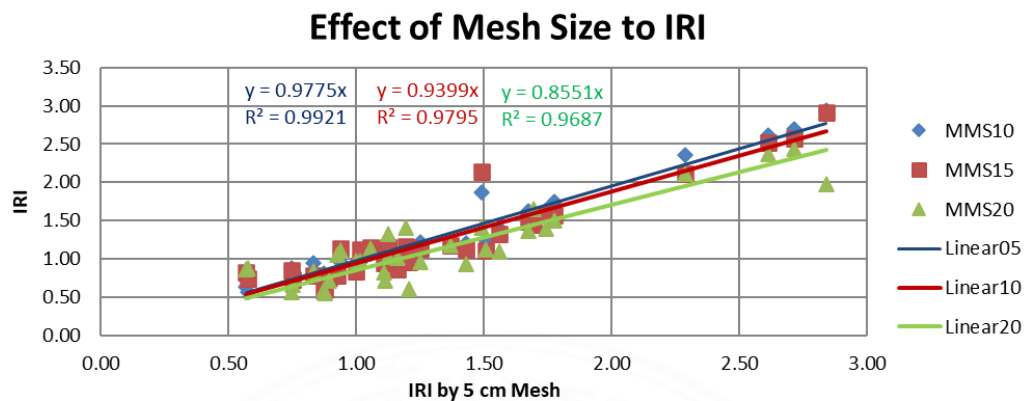
Figure 4.22 Effect of mesh size on IRI

Figure 4.21. There were 17 input files generated for “Pavement inspection program” execution. Results yielded the values of rutting and IRI. The finest mesh 5x5 cm was used as a benchmark for this test. Results by “Pavement inspection program” are shown in **Figure 4.22** and **Figure 4.23**.

Mesh size of 10 cm gave the best linearity to 5 cm mesh size with R^2 value of about 0.992. The value was about 97.75% of 5 cm mesh size. Mesh size of 15 and 20 cm returned $R^2 = 0.979$ and 0.969 with the value of 93.9% and 85.5%, respectively. If the value of 95% was expected, it could be concluded that 10 cm can be used instead of 5 cm mesh size in order to reduce calculation time. Adjustment factor of 0.9775 will be used for IRI value adjustment. Effect of mesh size to rut depth is as follow.

compared to the mesh size of 5 cmx5 cm. It was found the mesh size of 10 cm, 15 cm, and 20 cm resulted in R^2 values of 0.992, 0.979, and 0.969 when compared with the results of the mesh size of 5 cm. A mesh size of 10 cm resulted in a reduction of IRI by 95%.

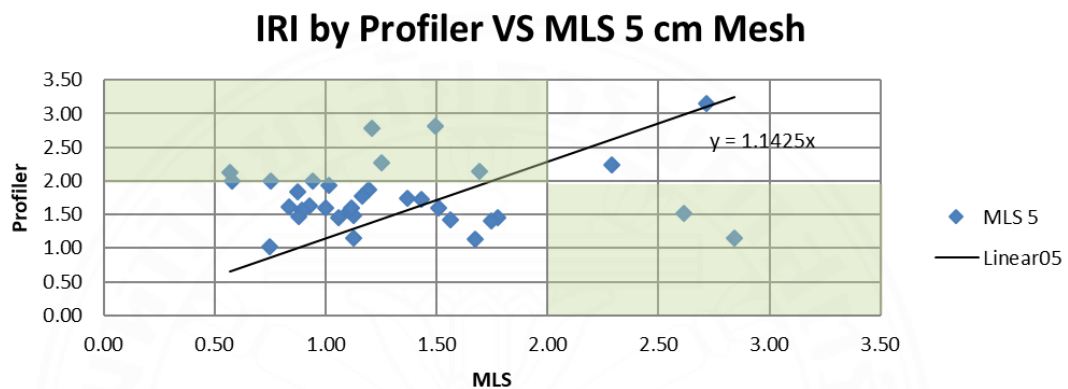
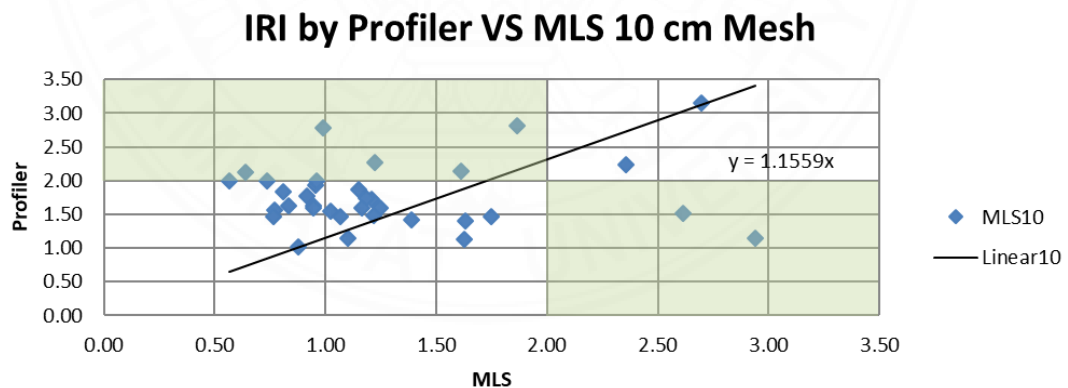
By graphs, IRI relations between 2 methods were observed in **Figure 4.24** and **Figure 4.25**. Mesh size of 5 and 10 cm, respectively were used for MLS IRI calculation. Correlation between these 2 methods could not be observed. It was found that IRI by MLS both 5 and 10 cm mesh must be multiplied by 1.142 and 1.156 to obtain the IRI

- IRI values by profilometer were used as a benchmark. In order to convert the IRI value obtained by MLS to IRI values obtained by a profilometer, empirical correlations between 2 methods were proposed. An R^2 of up to 0.933 for the value of IRI over 1.50-3.0 m/km was obtained from the comparison of IRI values obtained by MLS and profilometer. To convert the IRI value obtained from MLS to the corresponding profilometer value, a conversion value of 0.7597 should be used.
- It was found that the rutting values obtained from MLS measurements were significantly higher than those obtained from the profilometer.

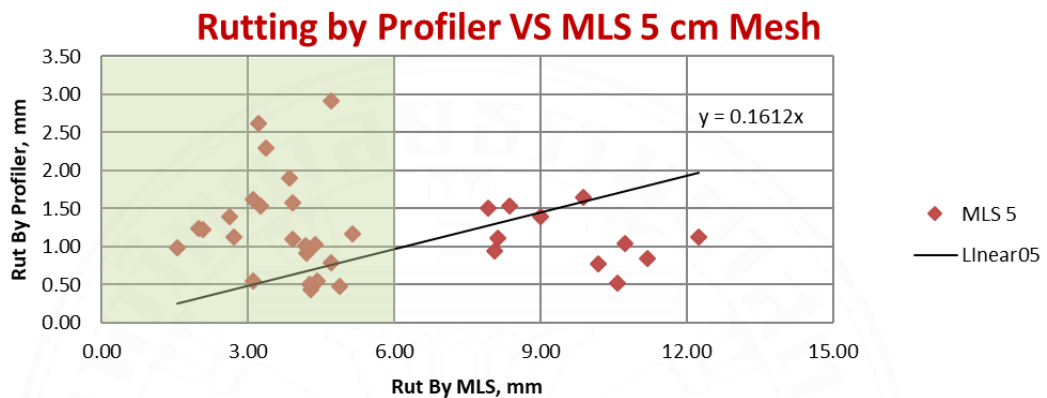
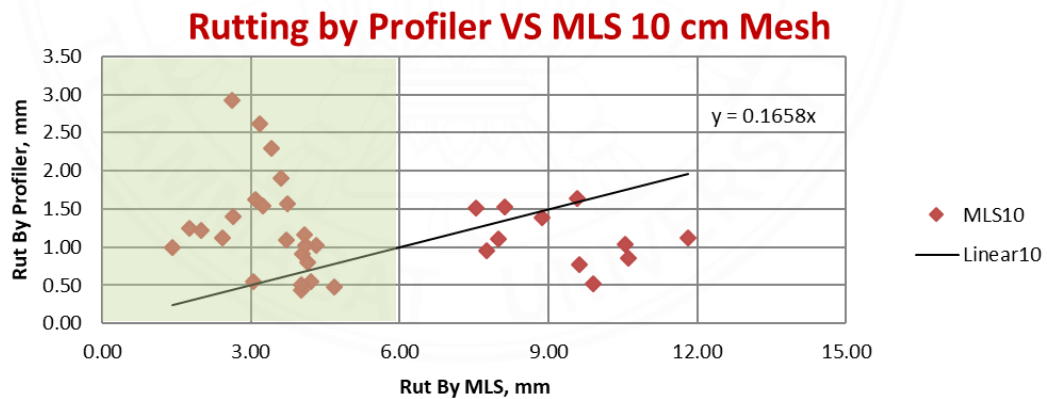
measured by profilometer will be only $= 0.1183 \times 12 = 1.42$ mm which is more realistic. Correlation between these 2 methods could not be observed as well.
