**STUDY ON INSPECTION AND EVALUATION OF  
DAMAGED STEEL STRUCTURE IN THAILAND**

**A THESIS SUBMITTED IN PARTIAL FULFILLMENT OF THE  
REQUIREMENTS FOR THE DEGREE OF MASTER OF SCIENCE  
(ENGINEERING AND TECHNOLOGY)**

**SIRINDHORN INTERNATIONAL INSTITUTE OF TECHNOLOGY**

**ACADEMIC YEAR 2015**

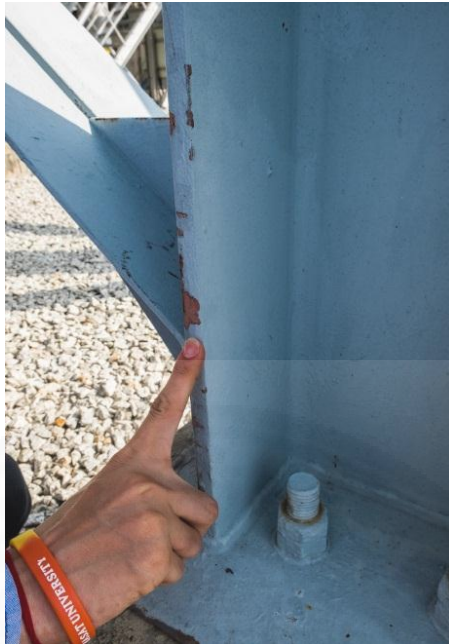
Fig 4.5 Flaking of anti-corrosive paint at Power Plant A

Fig 4.5 shows the flaking of an anti-corrosive paint, which covered around 1% of the flaked area with the size of 10 mm flaked areas

Figures	Damage type	Degrees of damage	Photo Ref.*
Fig 4.5	Flaking	Degree of Flaking 3(S3)	Fig. B-13
Fig 4.6	Flaking	Degree of Flaking 4(S3)	Fig. B-12
	Blistering	Degree of Blistering 4(S4)	Fig. B-3
	Rusting	Degree of Rusting Ri 4(S4)	Fig. B-8
Fig 4.7	Rusting	Degree of Rusting Ri 2(S3)	Fig. B-6
Fig 4.8	Flaking	Degree of Flaking 2(S3)	Fig. B-13
	Blistering	Degree of Blistering 4(S4)	Fig. B-3
	Rusting	Degree of Rusting Ri 3(S4)	Fig. B-7
Fig 4.9	Flaking	Degree of Flaking 4(S3)	Fig. B-12
	Blistering	Degree of Blistering 5(S3)	Fig. B-2
	Rusting	Degree of Rusting Ri 4(S3)	Fig. B-8

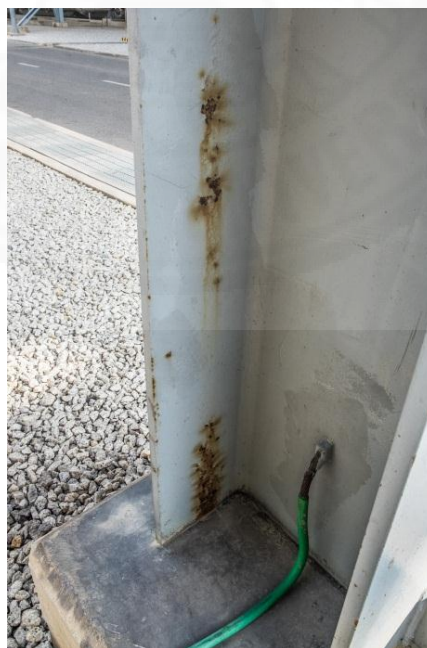
Fig 4.6 Blistering and rusting of anti-corrosive paint at Power Plant A

Fig 4.6 shows the blistering and rusting damage on the steel anti-corrosive paint and steel surface due to the moisture, size of defect is around 0.5 mm to 5 mm.

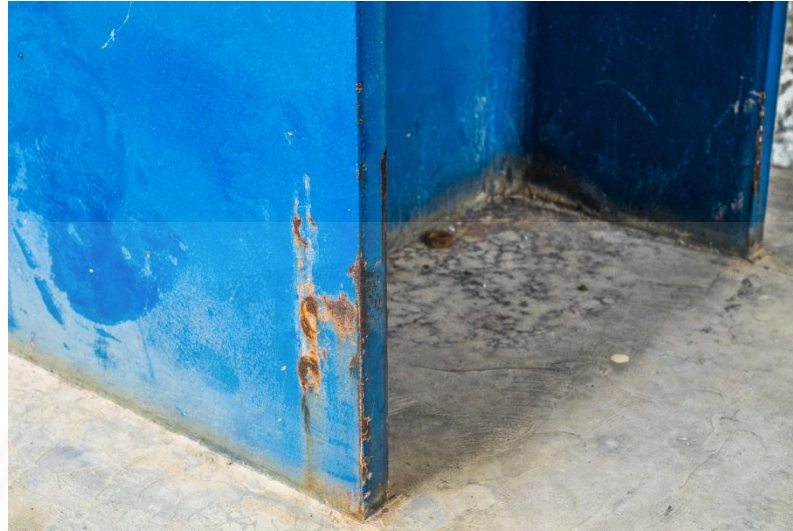
Fig 4.7 Rusting of anti-corrosive paint at Power Plant A

Fig 4.7 shows perceptible rusting on the steel surface, the rust cover only around 0.5% of the surface, and the size of damage is around 0.5 mm.

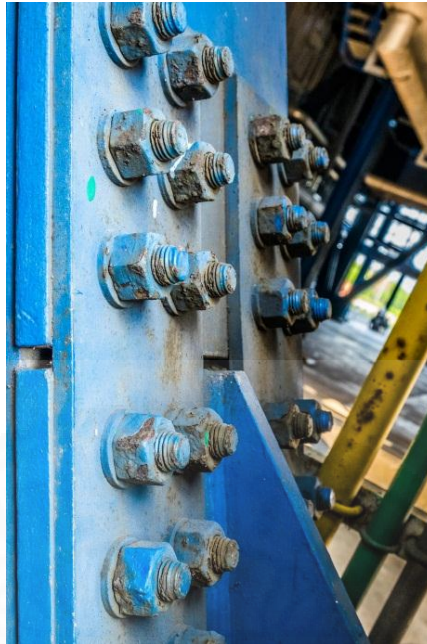
Fig 4.9 Blistering and flaking of paint on bolt at Power Plant A (2)

Fig 4.8 and Fig 4.9 show the damage on the bolt connection due to the deterioration of the coating and corrosion.

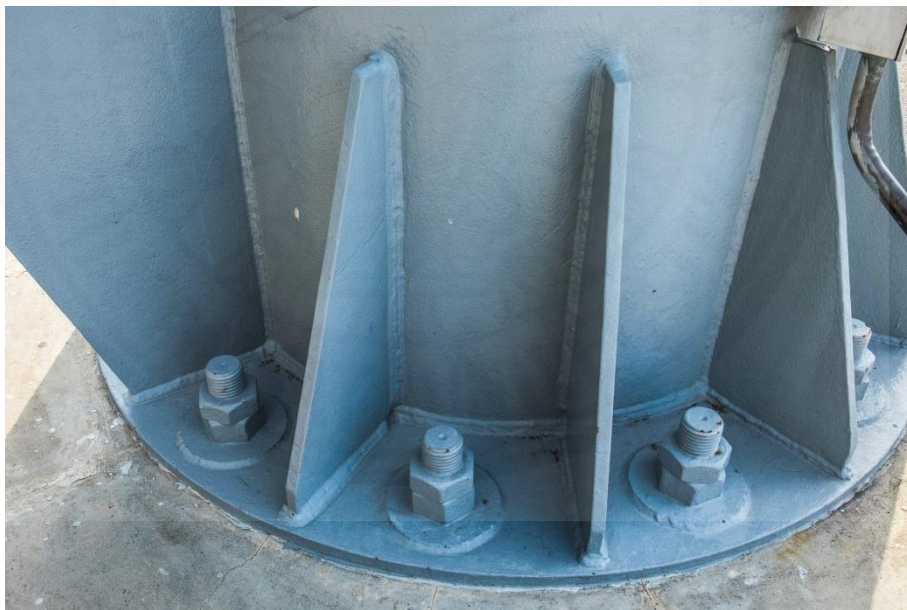
Fig 4.10 Weld and bolt connection of steel column at Power Plant A

This constructing method makes the quality of the welds to be good because of the quality control system of the fabrication factory is good (usually fabrication factory used inspection criteria based on American standards or Japanese standards). As well as the weld connection, steel bolt connection is also good since there is no damage or loose bolt found during the inspection, and the coating at the bolt is acceptable since the coating did not damaged during the installation work shows that the coating work is done after the installation as shown in Fig 4.10.

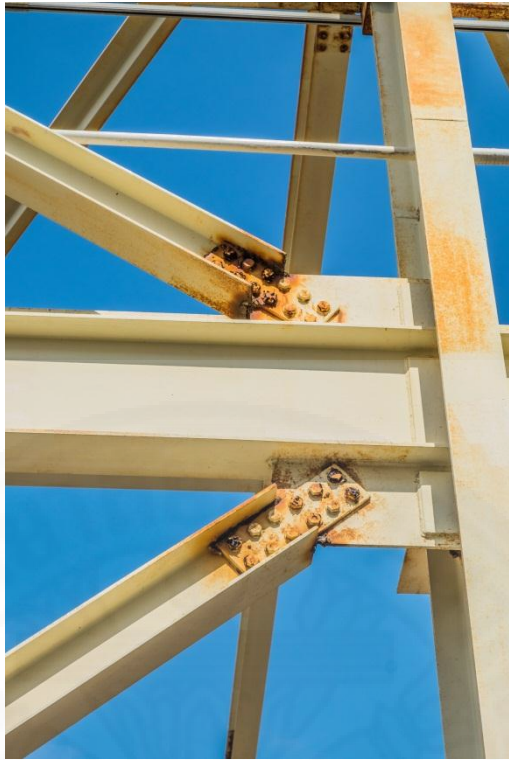
Fig 4.14 Corrosion on the steel bolt connection at Power Plant B (1)

Shown in Fig 4.13 to Fig 4.15 is the corrosion damage on steel bolt connections, the corrosion covers on both bolt itself and the steel plate which used to connect each steel section with the bolt, some of the connection was entirely covered by corrosion.

<b>Figures</b>	<b>Damage type</b>	<b>Degrees of damage</b>		<b>Photo Ref.*</b>
Fig 4.13	Rusting	Degree of Rusting	Ri 5(S5)	Fig. B-9
	Flaking	Degree of Flaking	5(S5)	Fig. B-12
Fig 4.14	Rusting	Degree of Rusting	Ri 5(S5)	Fig. B-9
	Flaking	Degree of Flaking	5(S5)	Fig. B-12
Fig 4.15	Rusting	Degree of Rusting	Ri 5(S5)	Fig. B-9
	Flaking	Degree of Flaking	5(S5)	Fig. B-12
Fig 4.16	Blistering	Degree of Blistering	4(S5)	Fig. B-4
	Rusting	Degree of Rusting	Ri 4(S5)	Fig. B-8
	Flaking	Degree of Flaking	4(S5)	Fig. B-12
Fig 4.17	Rusting	Degree of Rusting	Ri 5(S5)	Fig. B-9
Fig 4.18	Rusting	Degree of Rusting	Ri 5(S5)	Fig. B-9
Fig 4.19	Rusting	Degree of Rusting	Ri 5(S5)	Fig. B-9
	Flaking	Degree of Flaking	4(S5)	Fig. B-12

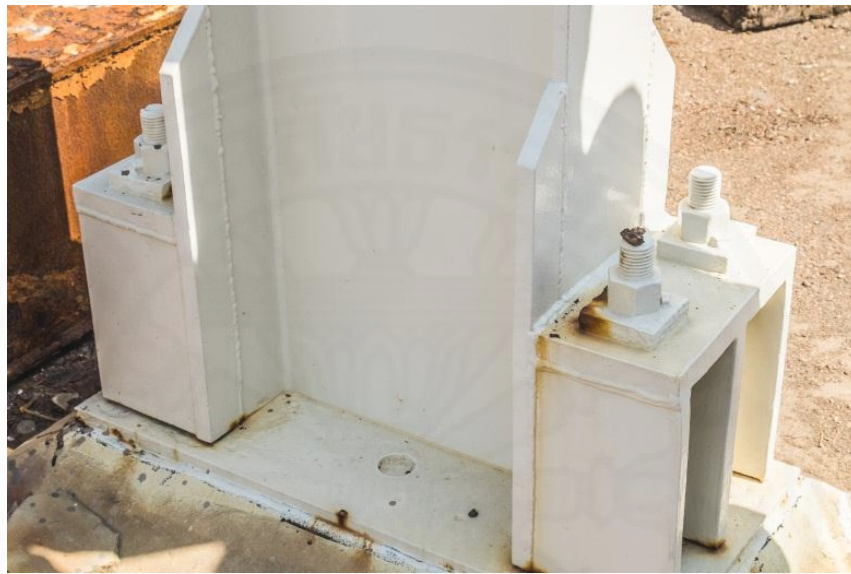
Fig 4.21 Weld and bolt connection of steel column at Power Plant B

Unlike the other power plants, the steel structure in Power Plant B was welded, bolted, and painted at the site. This may explain the reason why the steel structure in Power Plant B got many damage and defect. Even though, weld and bolt connection was acceptable (shown in Fig 4.34), but poor paint workmanship could cause a lot of problem to the steel structure.

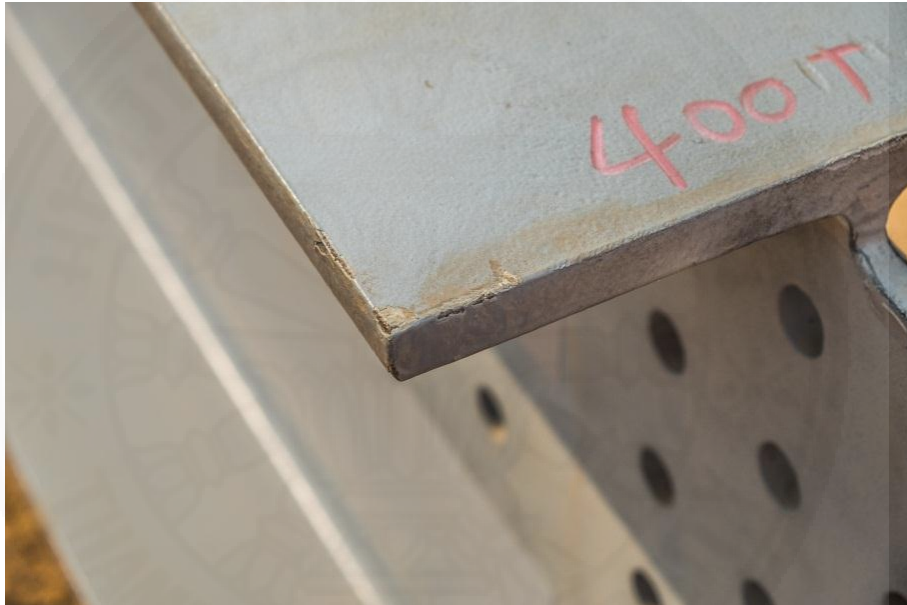
Fig 4.26 Anti-corrosive coating on the steel section at Power Plant C

The surface inspection results show that, the steel section at the connection site has no perceptible damage, since the steel was painted by anti-corrosive paint with many layers, shown in Fig 4.26 is the steel section that was fabricated and painted from the factory waiting for installation later on, the paint has many layers such as zinc coating, chromate coating, primer coating, and the paint (Top finish) coating etc.

Figures	Damage type	Degrees of damage		Photo Ref.*
Fig 4.26	Rusting	Degree of Rusting	None	-
	Flaking	Degree of Flaking	1(S1)	Fig. B-12
Fig 4.27	Rusting	Degree of Rusting	Ri 5(S5)	Fig. B-9
	Flaking	Degree of Flaking	4(S5)	Fig. B-12

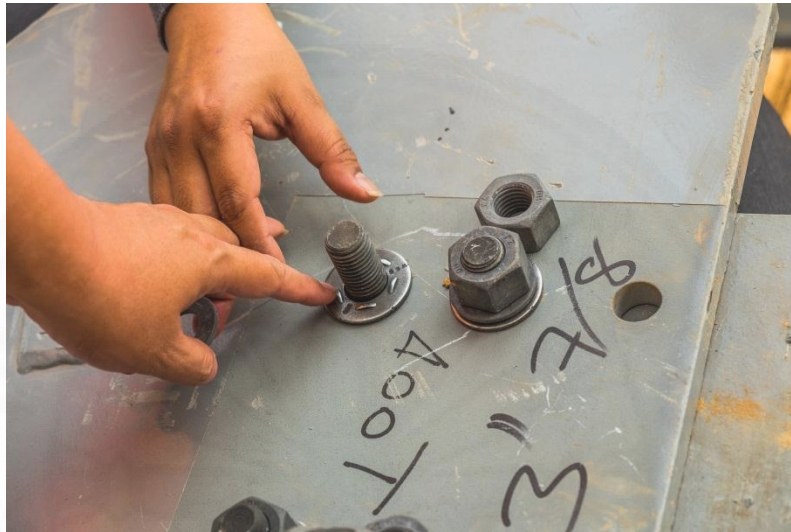
Fig 4.30 Indicator washer used in bolt connection at Power Plant C

The steel connection inspection results show that, in the construction site at Power Plant C had a good steel connection, as shown in Fig 4.30 the contractor used the indicator washers to indicate the tightness of the bolt connection, and the bolt was marked (shown in Fig 4.31 and Fig 4.32) after the bolt inspection (torque checking).

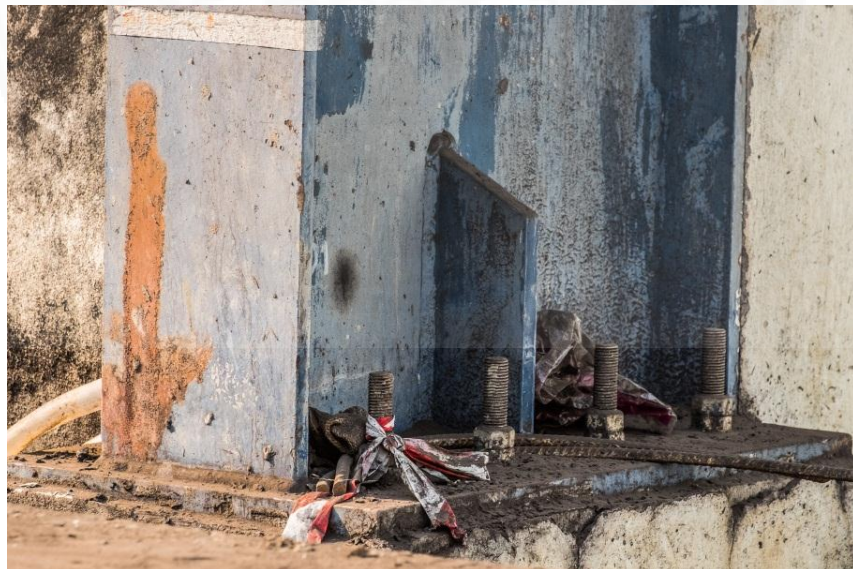
Fig 4.33 Steel weld and bolt connection at Power Plant C

The steel connection in the old power plant in Power Plant C (Fig 4.33 Steel weld and bolt connection at Power Plant C), has acceptable quality, since the steel section was fabricated from the factory and installed at the site.

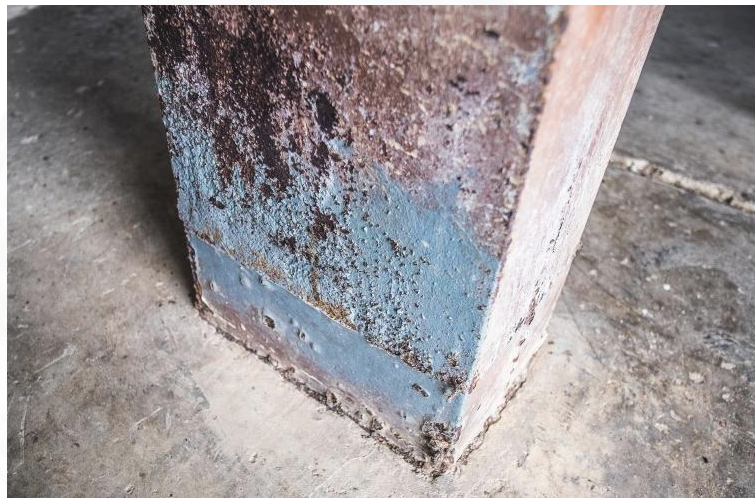
Fig 4.41 Corrosion on the steel column in Power Plant E

Fig 4.41 shows severe corrosion on the steel column in Power plant due to the small and dense blistering of the anti-corrosive paint.

<b>Figures</b>	<b>Damage type</b>	<b>Degrees of damage</b>		<b>Photo Ref.*</b>
Fig 4.41	Rusting	Degree of Rusting	Ri 4(S5)	Fig. B-8
	Blistering	Degree of Blistering	5(S4)	Fig. B-3
Fig 4.42	Rusting	Degree of Rusting	Ri 2(S3)	Fig. B-6
	Blistering	Degree of Blistering	2(S3)	Fig. B-2
Fig 4.43	Cracking	Degree of Cracking	4(S2)	Fig. B-10
	Rusting	Degree of Rusting	Ri 2(S3)	Fig. B-6
Fig 4.44	Flaking	Degree of Flaking	4(S5)	Fig. B-12
	Rusting	Degree of Rusting	Ri 5(S4)	Fig. B-9
Fig 4.45	Flaking	Degree of Flaking	4(S4)	Fig. B-12
	Rusting	Degree of Rusting	Ri 4(S4)	Fig. B-8

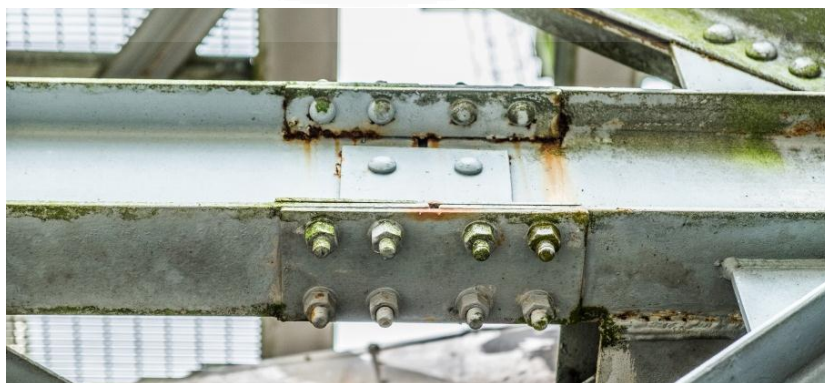
Fig 4.42 Rusting and blistering on the steel bolt in Power Plant E

Fig 4.42 shows some minor rusting and blistering at the steel bolt connection occurred from the moisture that penetrate in to the steel connection.

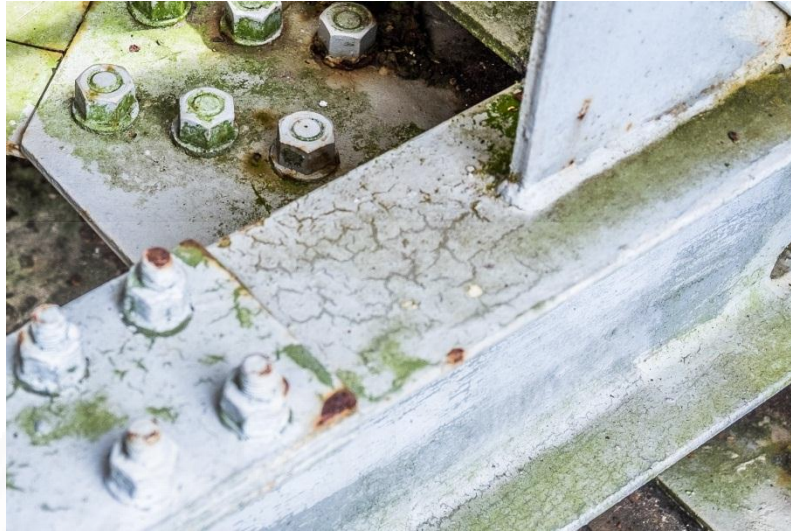
Fig 4.43 Cracking of the anti-corrosive paint in Power Plant E

Fig 4.43 shows some cracking of the anti-corrosive paint due to the high temperature of surrounding environment.

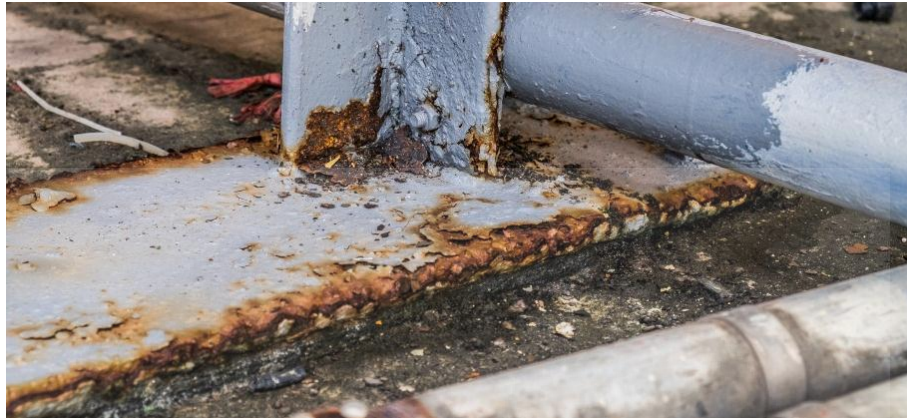
Fig 4.45 Flaking of the anti-corrosive paint as Power Plant E

Fig 4.45 shows the corrosion damage on the steel plate, occurred by the moisture that penetrated into the steel surface that was exposing by the flaking of the anti-corrosive paint.

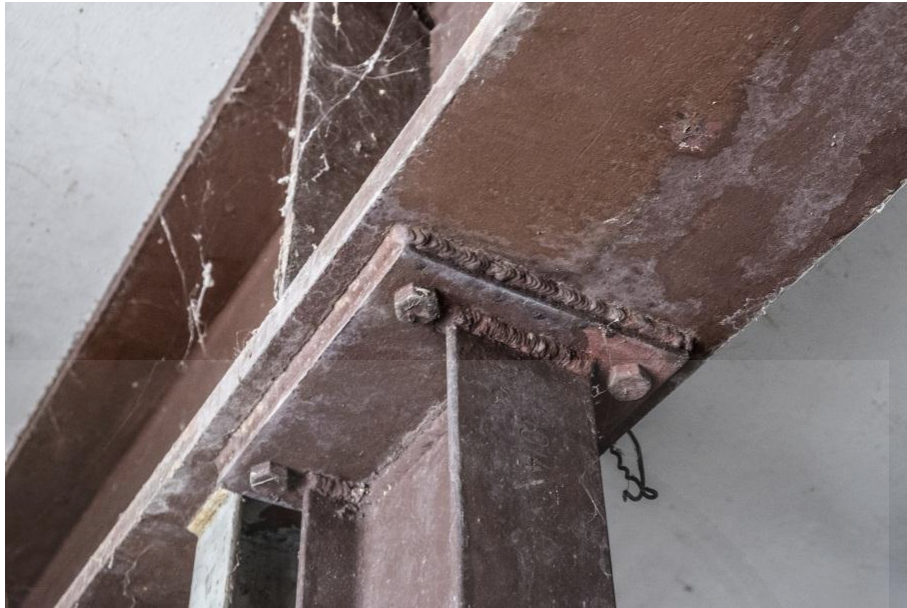
Fig 4.47 Weld connection of the steel structure in Power Plant E

Steel connection inspection results show that the steel connection used in Power Plant E are mostly bolted connection which were constructed nicely (shown in Fig 4.46), but some of the connection of a steel structure in Power Plant E was welded together at the site (as shown in Fig 4.47) since the quality of the welds is not good but still in the acceptable range.

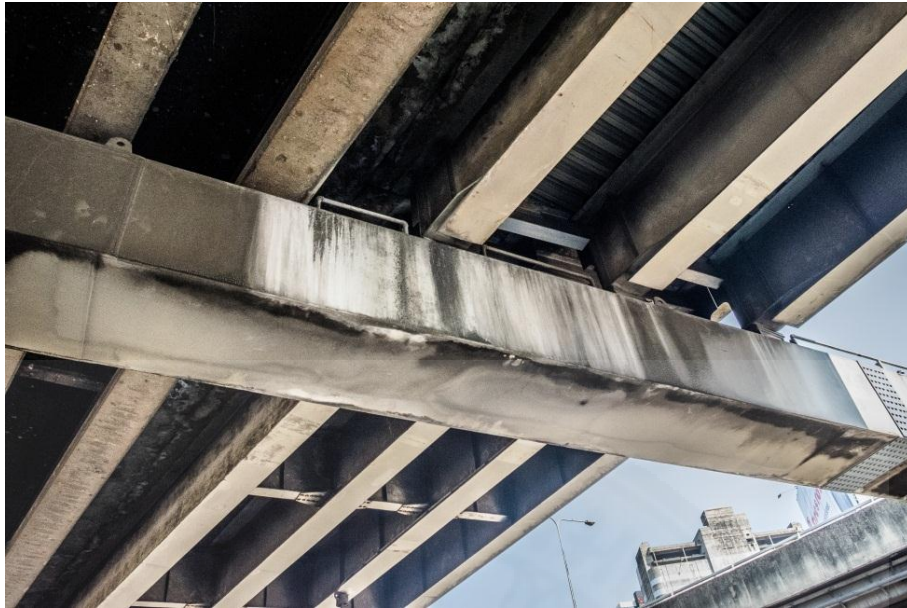
Fig 4.51 Lichen on the steel surface at Highway Bridge A

Inspection of steel highway bridge has to carry out by using patrol car for transportation around the site and parked in the parking zone under the highway bridge for safety, the result shows that for steel Highway Bridge A is in fair condition, minor damage found on the steel structure are mostly coating damage from the deterioration of the paint and some of the lichen cover the surface of the steel (high humidity area) as shown in Fig 4.50 and Fig 4.51.

Figures	Damage type	Degrees of damage	Photo Ref.*
Fig 4.50	Flaking	Degree of Flaking 5(S5)	Fig. B-12
Fig 4.51	Intensive of change	Change in intensity of color 5	-
Fig 4.52	No damage	-	-
Fig 4.53	No damage	-	-

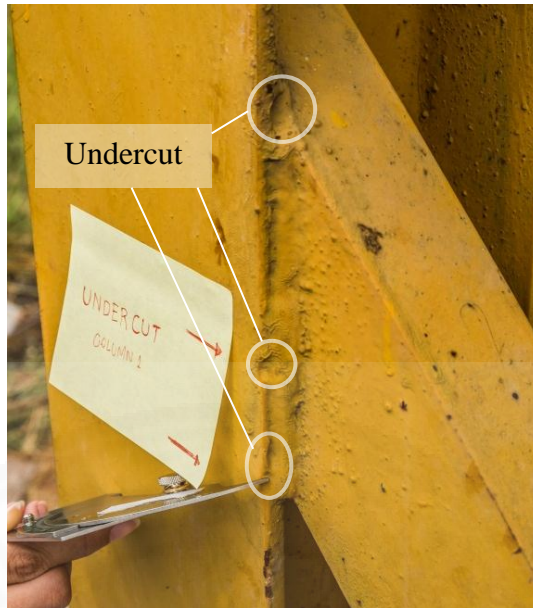
Fig 4.68 Welding defects on Billboard A (joint 2)

The inspection results show many serious weld defects mainly porosities and undercuts at the welding, the inspection results was recorded in the form of table (Table 4.8), which shown the size of the defect (depth and diameter) on each welds in relation with the figures of each joint, as in the figure shows the location of defect (see Fig 4.67 to Fig 4.72).

Figures	Thickness of Steel (mm)	Size of weld (mm)	Type of Weld	Defect of Weld <sup>a</sup>		
				Crack	Porosity <sup>b</sup> (mm)	Undercut <sup>c</sup> (mm)
Fig 4.67	10.0	150	Fillet Weld	-	10.5	-
Fig 4.68	10.0	150	Fillet Weld	-	-	2.5
Fig 4.69	7.5	150	Fillet Weld	-	15.0	-
Fig 4.70	10.0	75	Fillet Weld	-	-	3.0
Fig 4.71	10.0	150	Fillet Weld	-	12.5	-

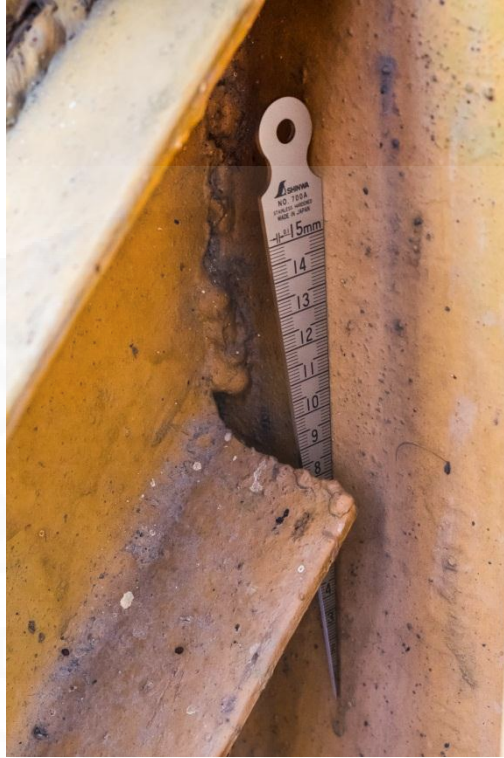
Fig 4.72 Welding defects on Billboard A (joint 6)

Shown in Fig 4.72 is a defect from poor workmanship which called “no-weld”, the steel section has no weld to connect them together makes the load transformation to be disable.

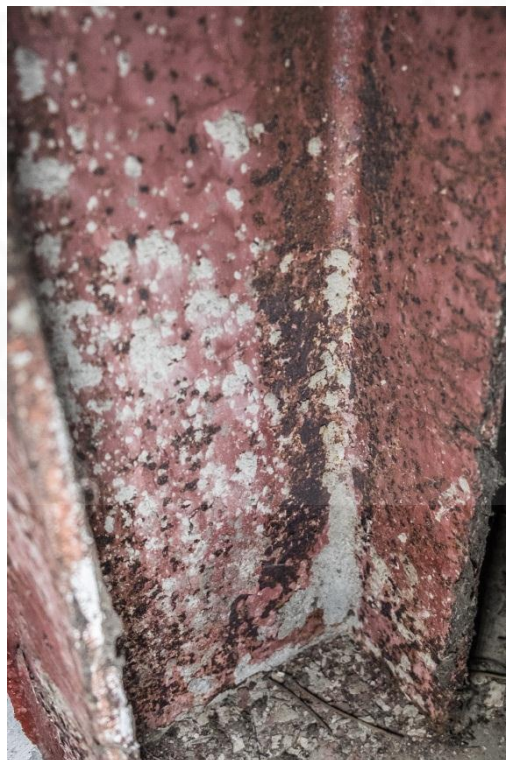
Fig 4.77 Corrosion on the steel column at Roof Structure A (4)

The inspection results show great amount of corrosion on the steel surface and some damage occurred on the steel section from the welding process

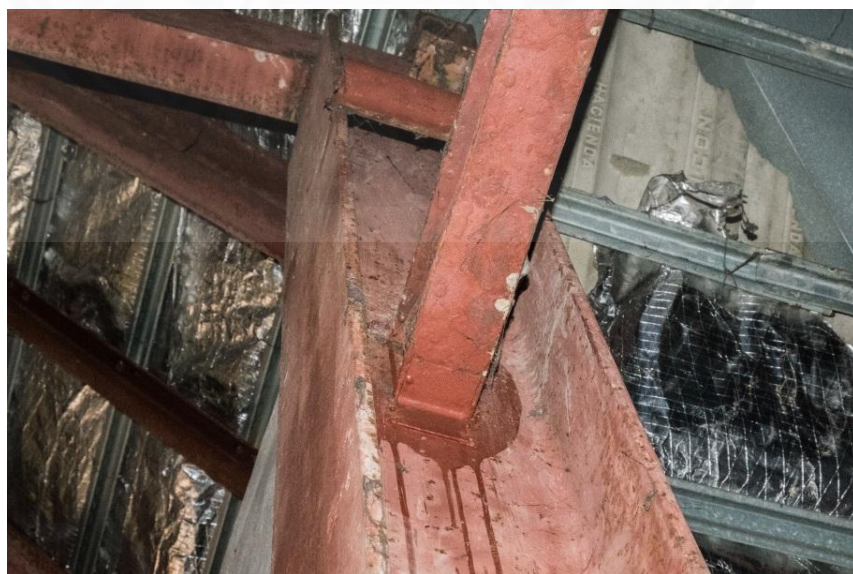
Fig 4.83 Weld connection of beam-column at Roof Structure A

The steel connection results show that the weld connection on the roof structure is not good based on its appearance, since the connection was constructed at the site, so the quality control is poor so as the workmanship of the workers. Fig 4.83 shows the steel welded connection (beam-column) of the roof structure.

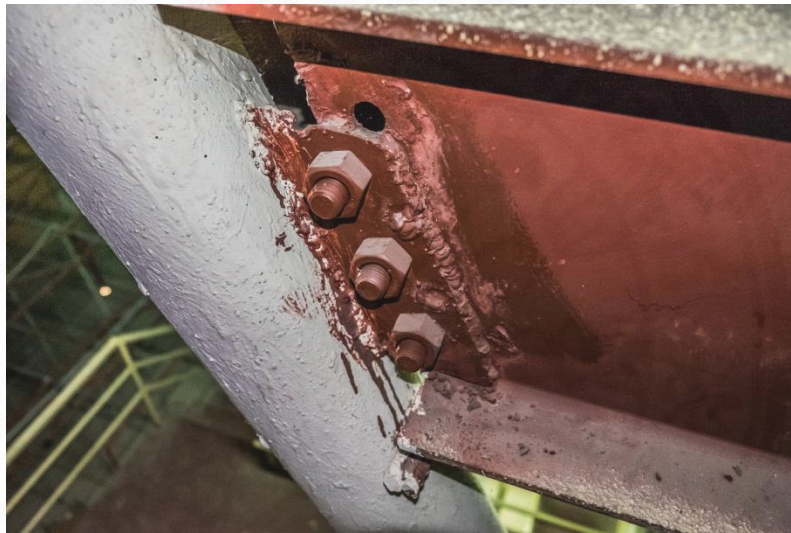
Fig 4.87 Undercut on the steel weld connection as Roof Structure B

Weld defect found on the weld surface is mostly undercuts and porosity as shown in Fig 4.87 and Fig 4.87. Also the sign of poor workmanship found in this structure is that some of the connection has the discontinuity of weld or incomplete welding as shown in Fig 4.89 to Fig 4.91.

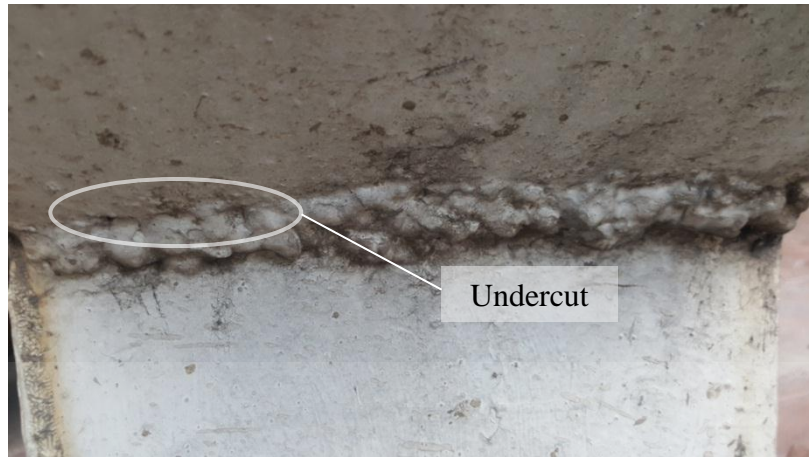
Fig 4.107 Welding defects on Steel Structure B (joint 5)

The inspection results show many weld defects mainly undercuts at the welding, the results was recorded in the form of table (Table 4.11), which shows the size of the defect (depth and diameter) on each welds in relation with the figures of each joint, as in the figure shows the location of defect (see Fig 4.103 to Fig 4.109).

Figures	Thickness of Steel (mm)	Size of weld (mm)	Type of Weld	Defect of Weld <sup>a</sup>		
				Crack	Porosity <sup>b</sup> (mm)	Undercut <sup>c</sup> (mm)
Fig 4.103	10.8	150	Fillet Weld	-	-	1.0
Fig 4.104	10.8	150	Fillet Weld	-	-	0.5
Fig 4.105	10.8	150	Fillet Weld	-	-	1.7
Fig 4.106	10.8	150	Fillet Weld	-	-	2.8
Fig 4.107	10.8	150	Fillet Weld	-	-	1.1
Fig 4.108	10.8	150	Fillet Weld	-	-	1.5
Fig 4.109	10.8	150	Fillet Weld	-	-	1.7
